SITE MANAGEMENT PLANNING AT MUSAWWARAT ES-SUFRA, SUDAN: CONDITION ASSESSMENTS, CONSERVATION AND REHABILITATION MEASURES, AND THE DEVELOPMENT OF A FIRST VISITOR GUIDANCE SYSTEM

Great Enclosure (I A)⁷

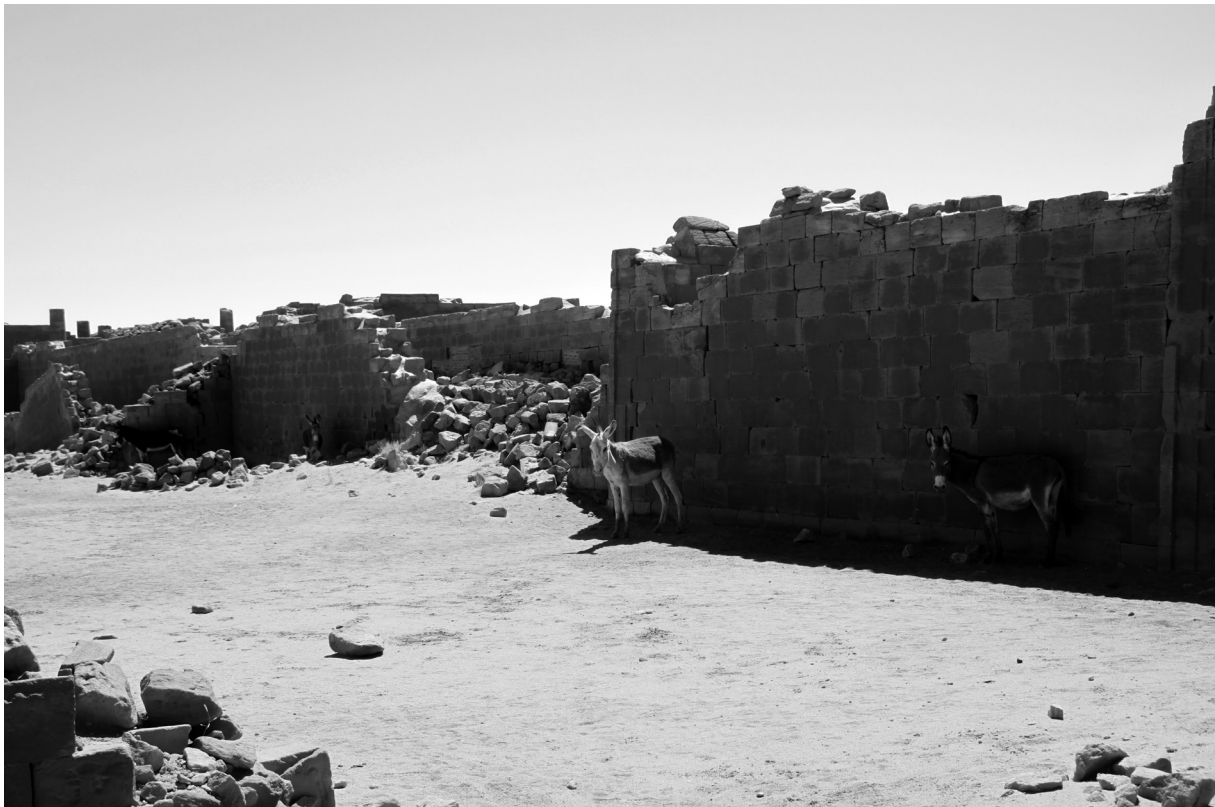
Fig. 1: Donkeys searching for shadow in the Great Enclosure (photograph: Cornelia Kleinitz)

ture change, corrosion (i.e. abrasion) through aeolian sand erosion as well as pressure relief. Missing capstones are the main reason for the loss of bond and the collapse of walls, which allow rain water to seep into the walls and destabilise their filling of earth mortar and rubble stones. Rain water also destroys the structure of the sandstone blocks by the mobilisation of soluble materials. Desquamation effects (i.e. the flaking of the outer block surfaces), are caused by daily temperature changes, whereas exfoliation along the block edges is caused by pressure relief. Other mechanical damage is mainly caused by animals, primarily goats and donkeys, and to a lesser extent by visitors (fig. 1).

ideally also the Small and Smallest Enclosures. While a fence will alter the appearance of the site, damage caused by roaming animals, especially donkeys and goats, has now reached a degree that necessitates drastic measures for the protection of the building complexes. Planning for the route, the height and type of fence resulted in the decision to follow the general outline of the Great Enclosure and install a metal mesh fence to a height of 1.50m, with metal poles fastened into the ground with concrete foundations to a minimum depth of 0.50m.³⁴ Issues to be resolved concern 1) the location of the fence to the east of the Great Enclosure, along the course of the wadi, 2) the rehabilitation of the southeastern corner of the Great Enclosure, which is not visible above ground and which has been cut by an earthen, curving demarcation wall installed in the 1960s, 3) the location of the car park, which needs to be moved in accordance with the development of a visitor guidance system and a new entrance area, and 4) the re-routing of the track from the Great Enclosure to the Lion Temple. The plans concerning the fencing of the named monuments and the re-designing of the surrounding areas were presented on site to the director of NCAM, Abdelrahman Ali Mohamed, in August 2014 and approved.

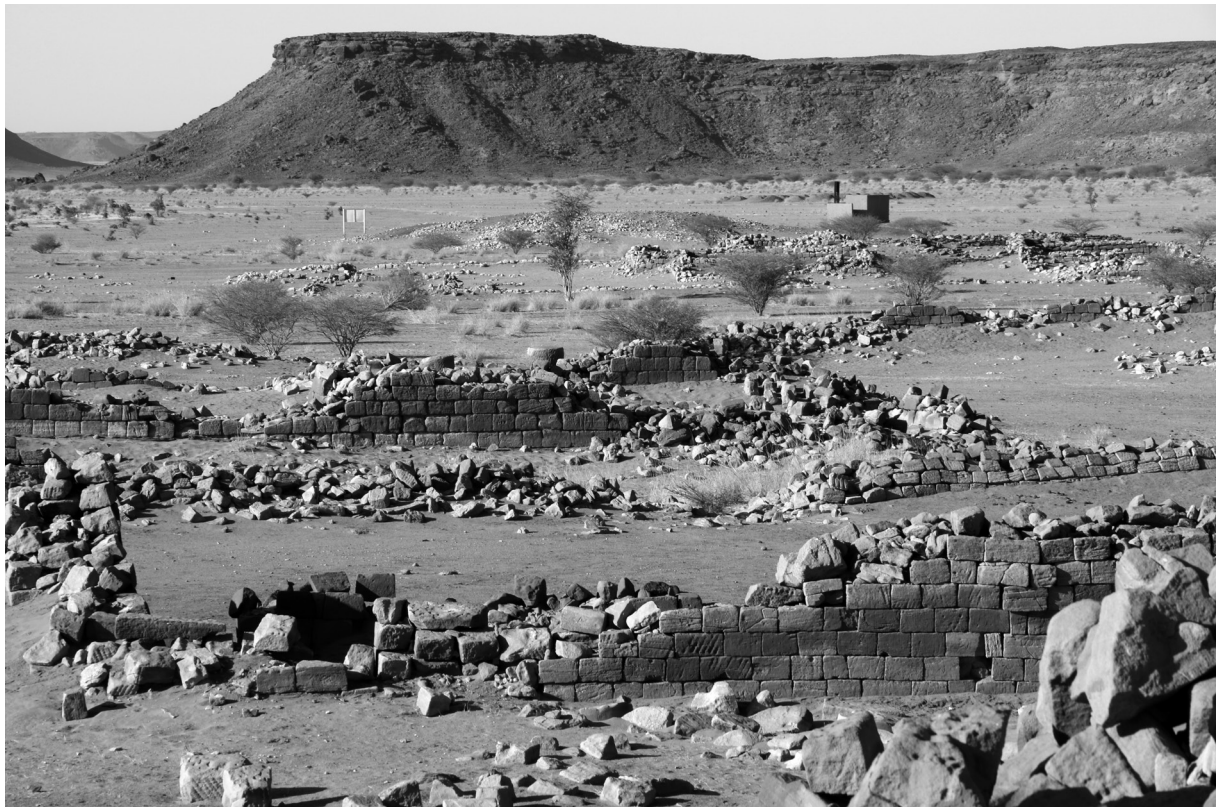
Fig. 2: View over the southern part of the Great Enclosure towards the Small Enclosure (I B) and the kom of debris from the excavation of the latter monument in the 1960s (photograph: Claudia Näser)

During the condition survey it was further noted that the numerous block repositories and spoil heaps which dot the perimeter of the Great Enclosure (and other parts of the site) make it often difficult to establish which features are ancient structures and which features are the result and debris of archaeological intervention (fig. 2). A concerted effort is needed for the rehabilitation of the perimeter of the monument.

The area immediately to the east of the Great Enclosure was subject to preparatory work for the implementation of a new visitor guidance system and the installation of a fence protecting the monument in the near future. The area had been used as a storage place for ancient building material from the Great Enclosure and rubble from excavations since the 1960s. The first steps have now been undertaken for its rehabilitation. A large heap of excavation debris was removed and deposited in the wadi bordering the Great Enclosure in the east in an attempt to prevent the further encroachment of this temporary river bed onto the monument (fig. 8). A second kom of excavation debris, situated south of the Small Enclosure and deriving from the excavation of this structure in the 1960s (see fig. 2), was also partly removed and deposited in the wadi. The area reclaimed from the

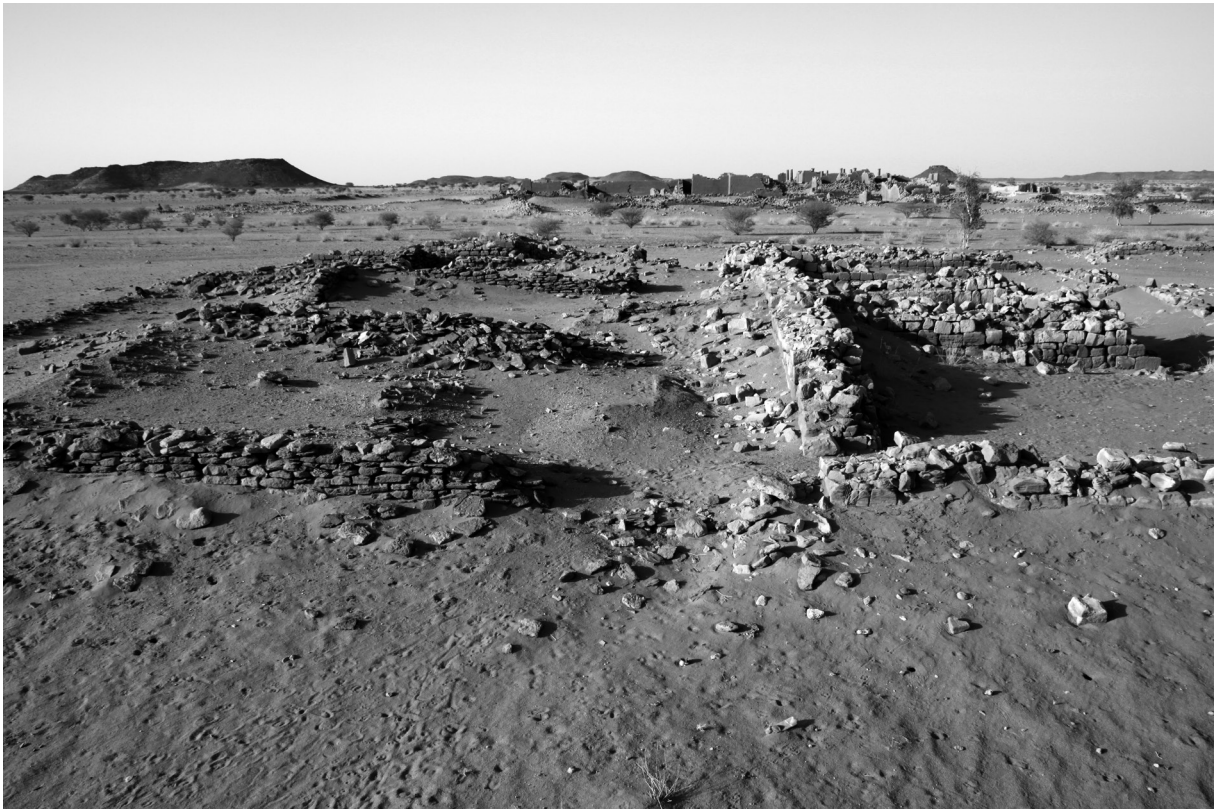
Deterioration of the walls of this monument (see fig. 3), which is located immediately to the south of the Great Enclosure and is preserved to a few block layers above ground, is today brought about primarily by animal action i.e. roaming donkeys and goats. To prevent further damage, the remains of the building should also be fenced urgently.

Fig. 3: The Small Enclosure (I B) south of the Great Enclosure (photograph: Cornelia Kleinitz)

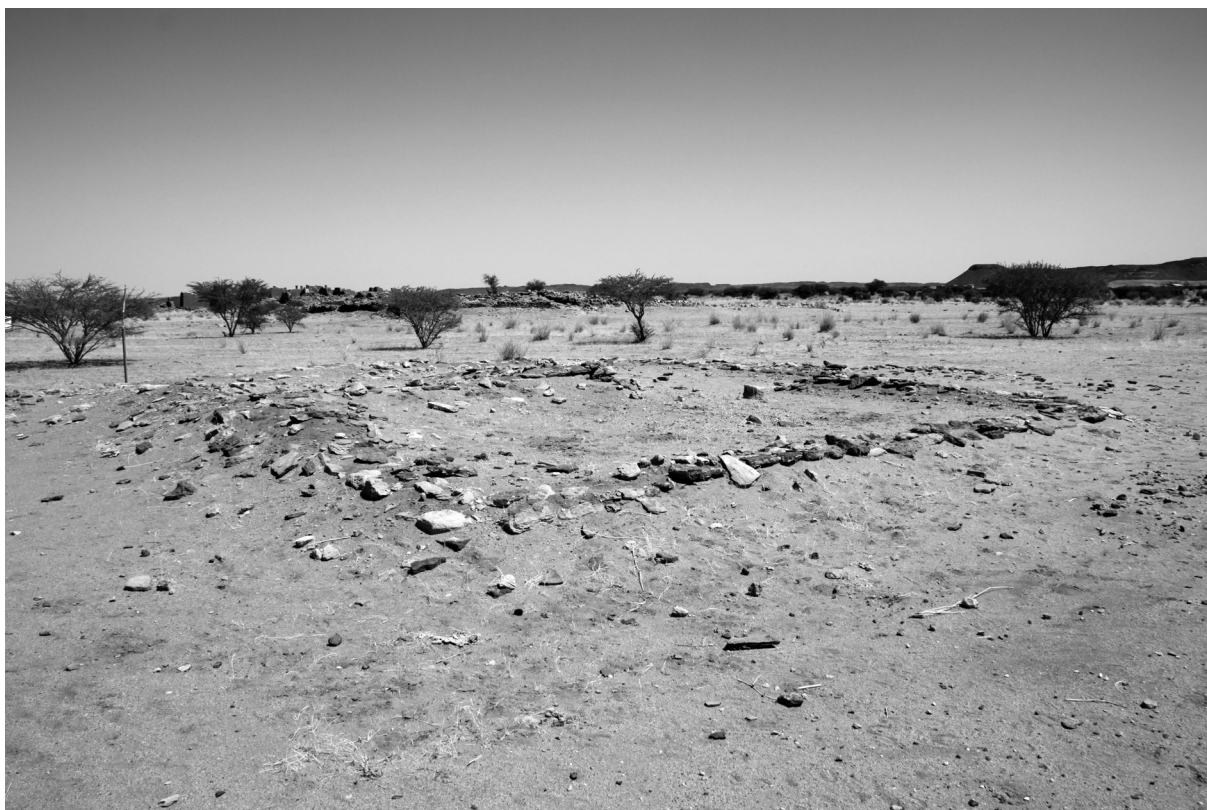
This inconspicuous monument is located in the immediate vicinity of the present tourist police station to the south of the Great Enclosure. It is only preserved at and below ground level and therefore in danger of not being recognised as an ancient structure. The tourist police, for example, had installed a pole and a barrel on its walls for gaining a better telephone signal (fig. 4). The Smallest Enclosure should also be fenced to avoid 1) its misuse and 2) cars driving over it. It should also receive interpretive signage to mark it as an ancient monument.

Fig. 4: The Smallest Enclosure (I C) south of the Small and the Great Enclosures (photo-graph: Cornelia Kleinitz)

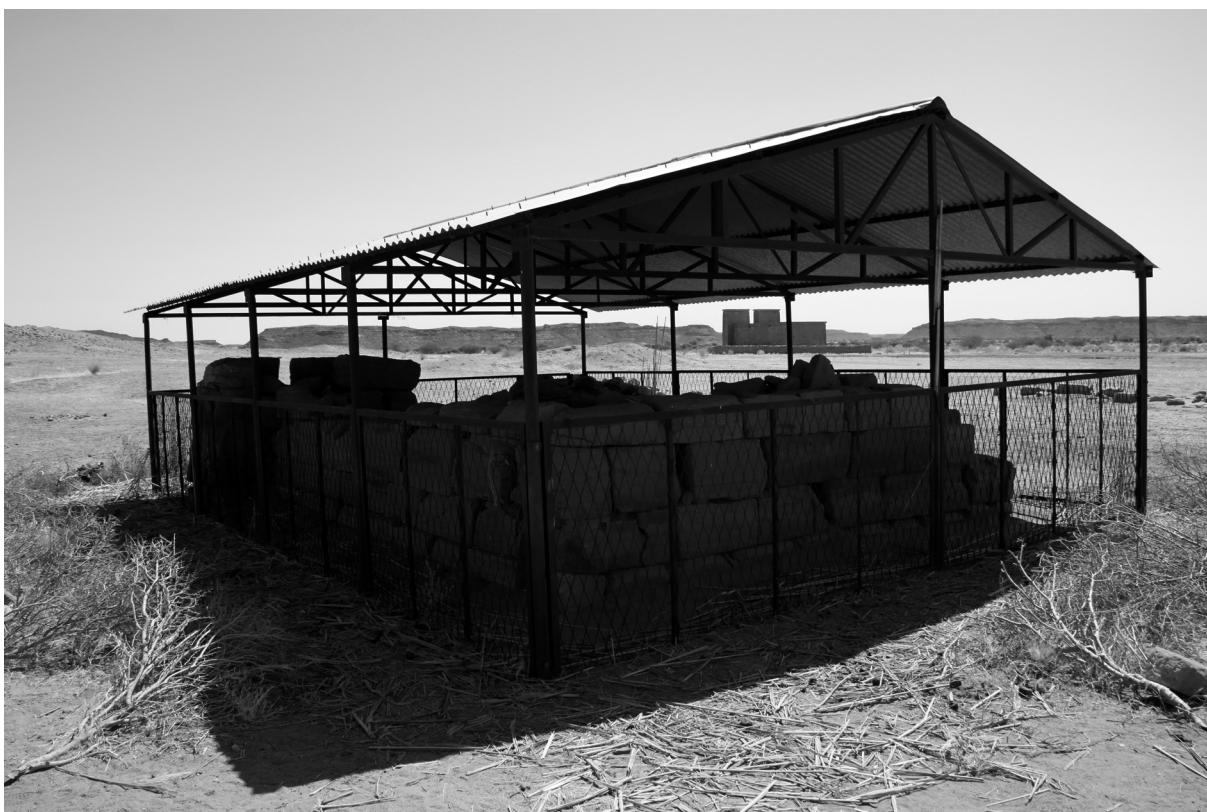
This small temple received a protective structure with a metal roof in 1995.⁸ Reed mats were fixed to the structure in order to limit wind and sand erosion; they had been renewed regularly. During the condition survey the usefulness of the reed cover as a wind and sand shield was discussed and found to be minimal. The reed cover was, therefore, not renewed (fig. 5). Conservation measures, which include the cleaning and consolidation of the wall reliefs, are urgently necessary at this temple. A quick inspection indicated that the reliefs appear to have suffered from the effects of (rain) water since their recovery, rather than from wind and sand erosion. This also questions the usefulness of the protective roof over the temple. Indeed, the roof may act as a sand and rain trap rather than protecting the temple. The covering also prevents the temple from being recognised as such in the landscape. Windblown sand should be removed from the monument every couple of years to prevent the storage of moisture and resulting damage to the reliefs. A protective lime mortar covering, similar to those of the Great Enclosure (see below), could protect the wall tops. The reliefs should be cleaned and

Fig. 5: Temple II A and its protective structure after the deterioration of its reed cover (photograph: Cornelia Kleinitz)

consolidated. Overall, Temple II A requires a thorough assessment of its state of preservation and of the effectiveness of the protection measures applied, such as its roofed protective structure.

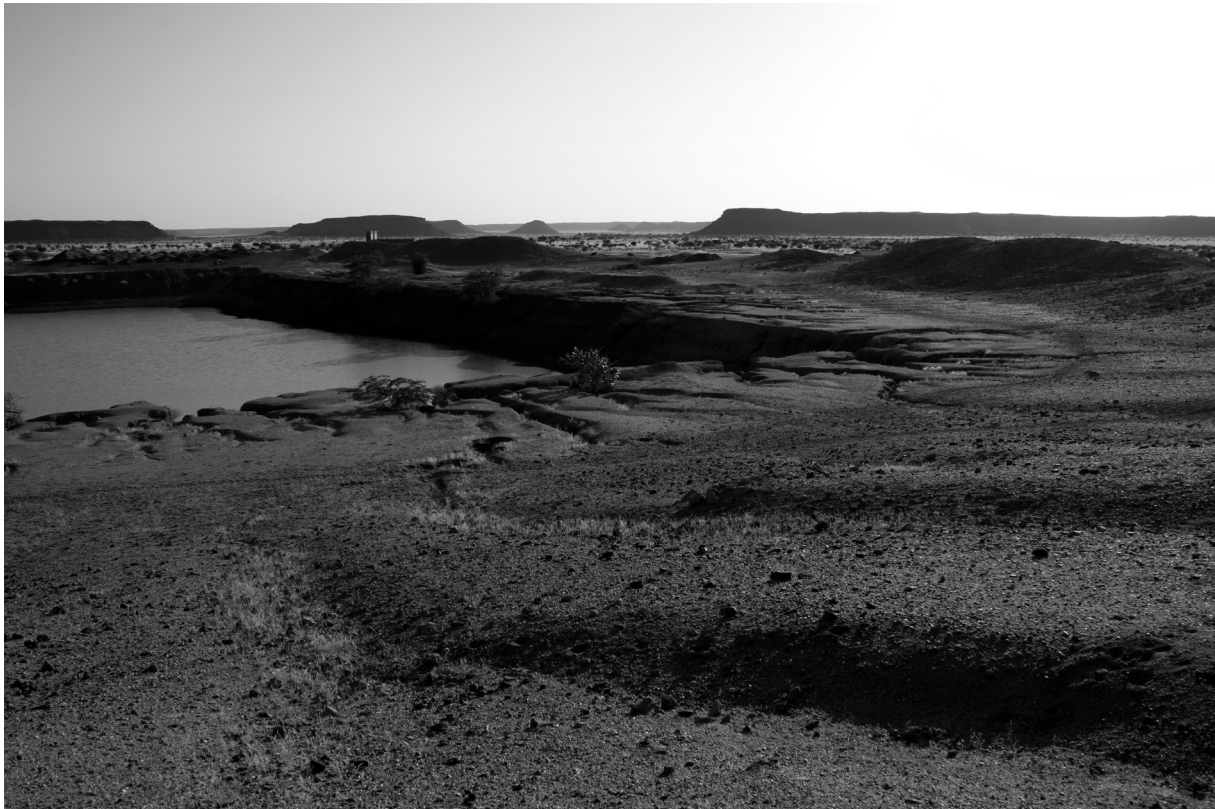
An unsolved problem are the myriad dump heaps from the mechanical digging activities of the Sudan Civilization Institute (2003, 2005 to 2006) in Musawwarat's largest ancient water reservoir, the Great Hafir. Heaps of deposits stretching along the flanks of the hafir, dot the valley of Musawwarat and the routes leading towards it.¹² The strong erosion of the hafir interior by runoff water was noted (fig. 6). Some remedial action was taken in respect to the heaps of hafir fill close to the Lion Temple (see below).

Fig. 6: The Great Hafir's interior with erosion channels (photograph: Cornelia Kleinitz)

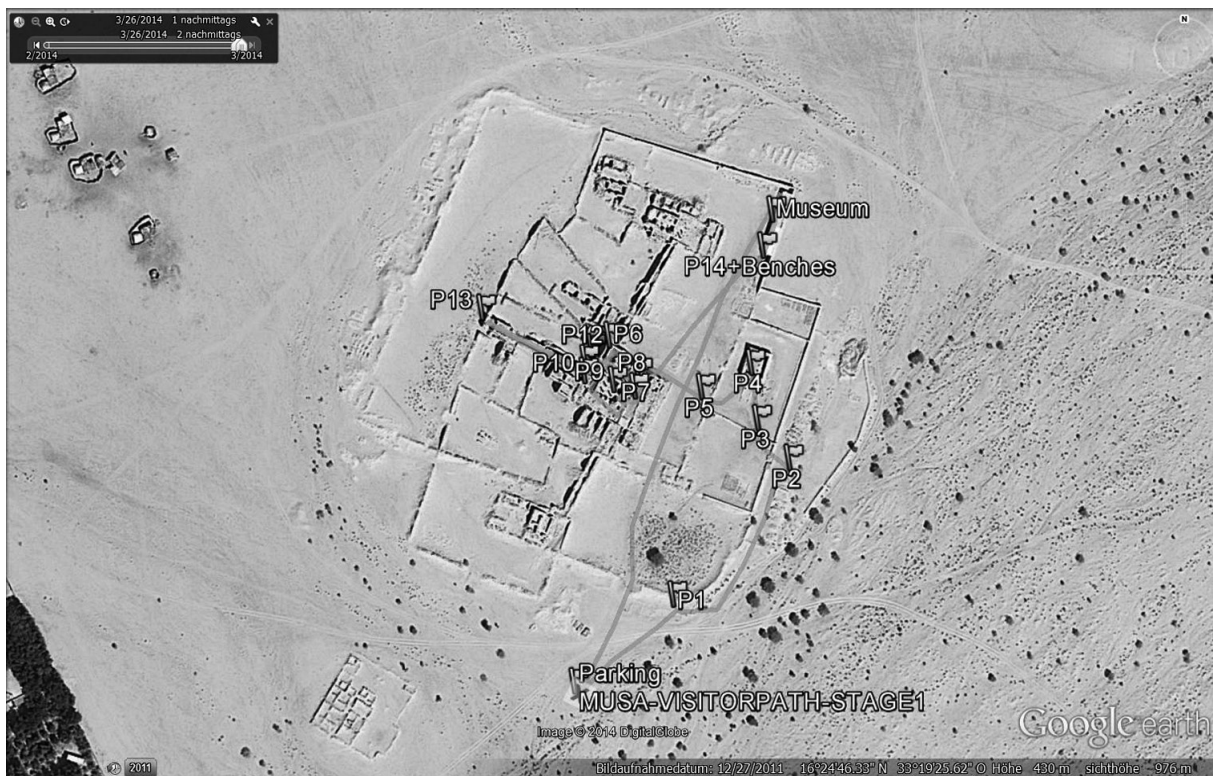
Fig. 7: The proposed visitation route, stage 1 (graphics: Google Earth and Cornelia Kleinitz)

For the Great Enclosure, a logical visitation route was developed with a number of view and information ‘hot spots’, which are to be equipped with information panels in the coming seasons. The route focuses on the eastern and central parts of the building complex (Complexes 300, 100 and 500), with its northern and southern parts (Complexes 200 and 400) deliberately omitted from this route as they need to undergo further study and consolidation before being opened for visitation. Overall, the visitation route – which can be extended at a future point – is suggested to follow the ancient routing through the site starting at the likely main entrance to the Great Enclosure (from the east into courtyard 305), passing Temple 300, accessing the Central Terrace via ramp 119, circling the Central Temple and finally arriving at the site museum (fig. 7). While visitors can become aware of the labyrinthine character of the site on this route, the route means they will cross (and damage) as few of the ancient walls as possible.

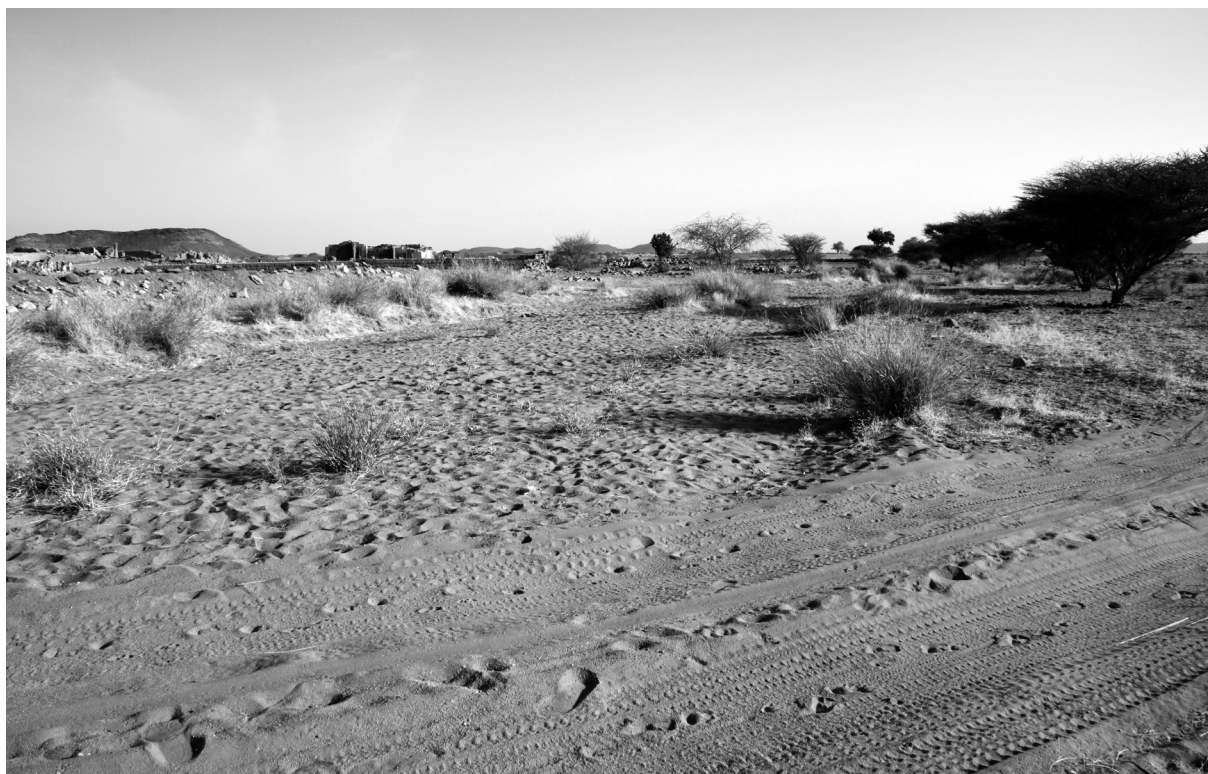
Fig. 8: The wadi east of the Great Enclosure, seen from the south, namely the 'old' track to the Lion Temple, prior to its re-design (photograph: Cornelia Kleinitz)

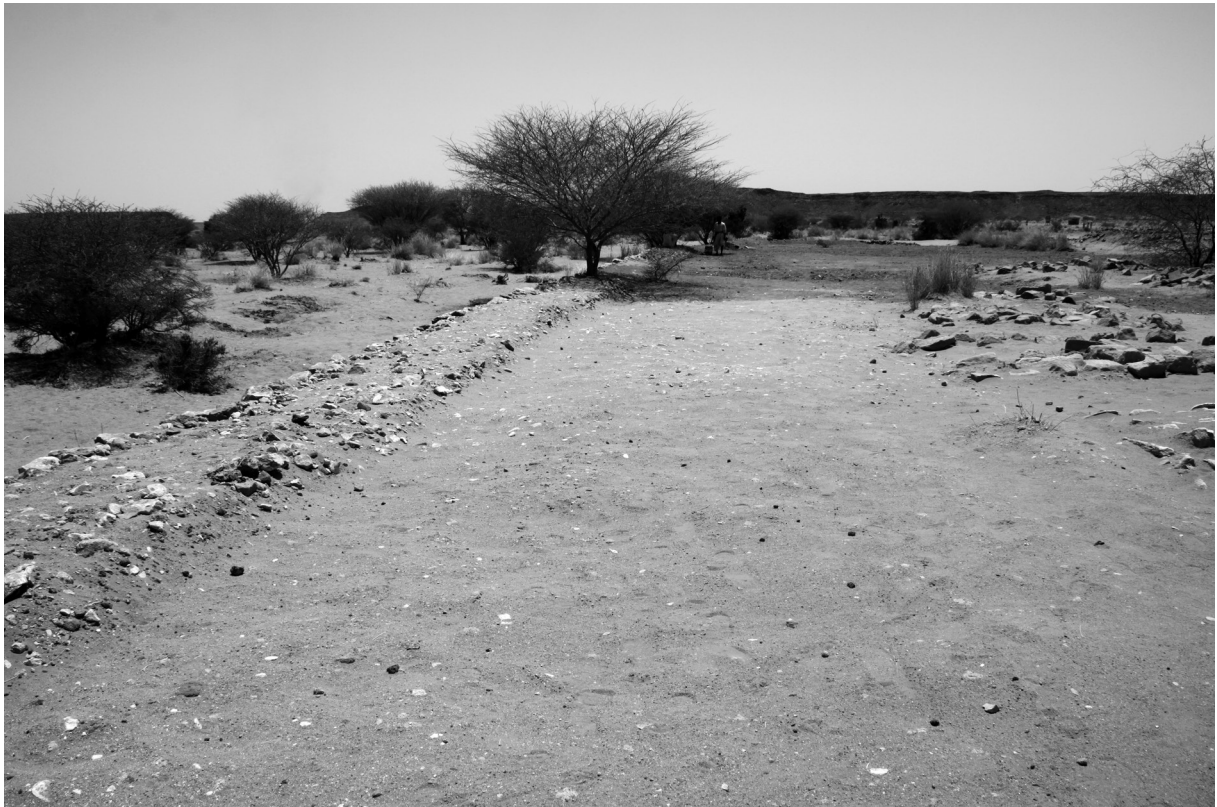
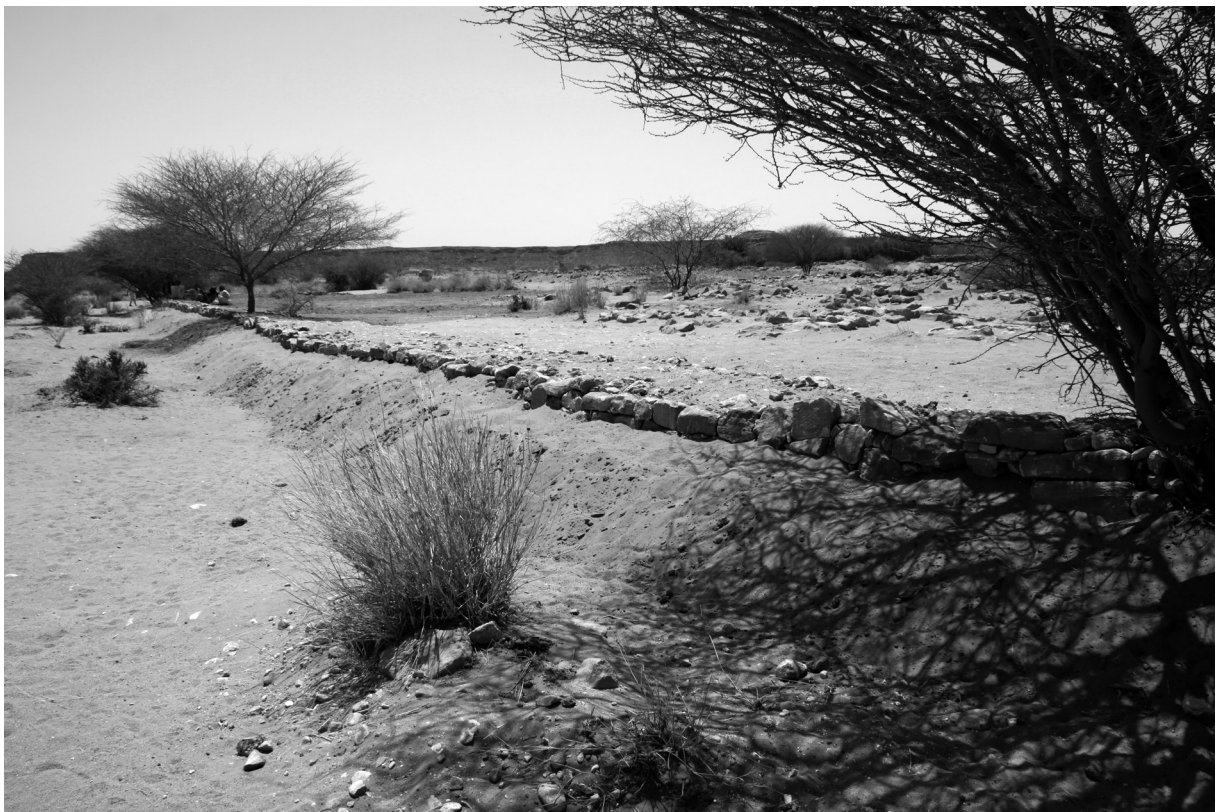
wadi by these measures was delimited and stabilised on its eastern side by a low wall. To prevent the impression that this wall is an outer wall of the Great Enclosure, its top was covered with sand and earth (figs. 9–10). The wall was covered on its eastern side with a low bank of sand to help protect it against the impending run-off water during the rainy season (fig. 10). This approach was successful, as the construction withstood the waters from the wadi during the 2014 rainy season and was still perfectly intact in October of that year.

Fig. 9: The area east of the Great Enclosure, seen from the north, after its re-design with a low rubble and earth platform bordered by a low wall towards the wadi (photograph: Cornelia Kleinitz)

Fig. 10: The area east of the Great Enclosure with the rubble and earth platform and the newly constructed wall, covered by sand and equipped with a bank of sand on the wadi side (photograph: Cornelia Kleinitz)

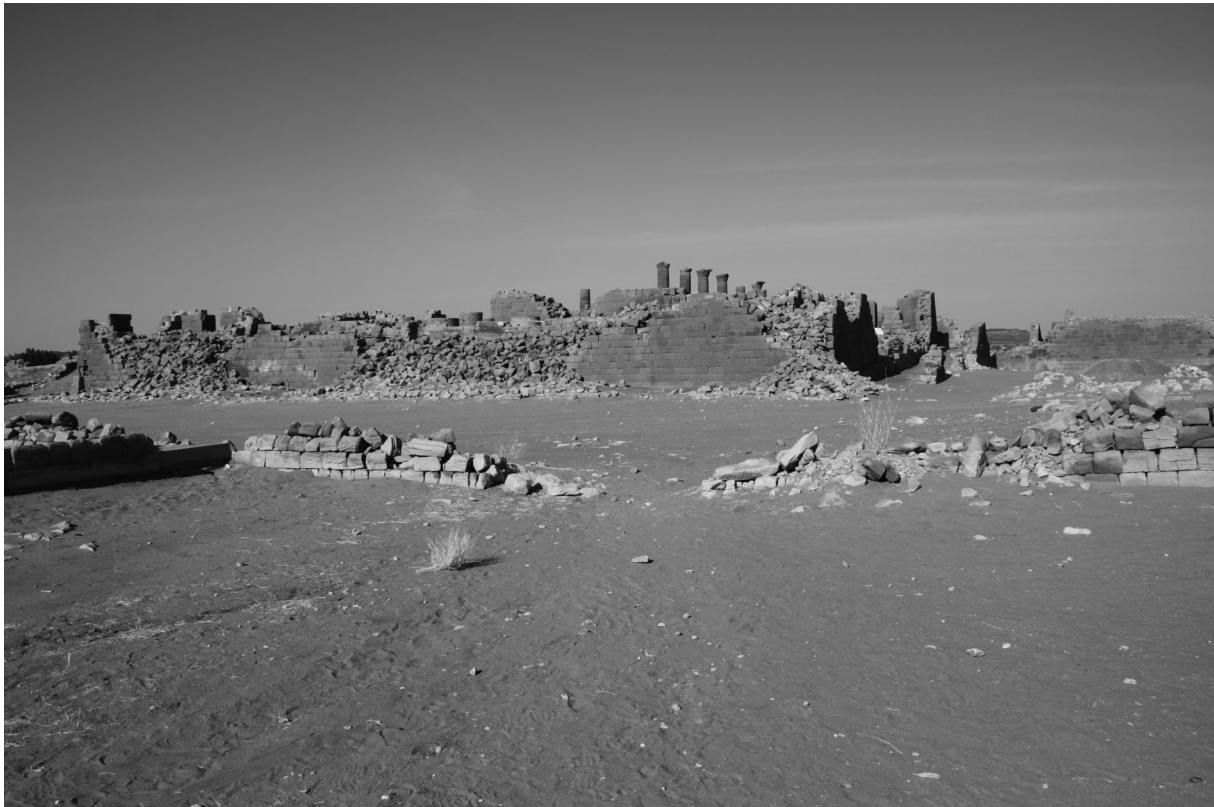
Fig. 11: Wall 117/304 with the gate towards courtyard 117 prior to conservation measures (photograph: Cornelia Kleinitz)

307/E (2008) and 307/N (2009) to the current conservation-restoration strategy.²⁰ On the basis of the findings of condition mapping at the Great Enclosure and the planning of a visitor guidance system (see above), the western wall of courtyard 304 with its gate to courtyard 117 was identified as a major point of concern as this area will become part of the main visitation route envisaged for the monument. The wall in question was in a poor state of preservation and sections of it were only visible above ground as rubble heaps (fig. 11). The movement of larger numbers of visitors through this area would have necessarily led to further destruction of these remains. The aim of the conservation-restoration project therefore was to expose and clearly identify the ancient building substance, to consolidate it in situ and rehabilitate the ancient gateway in a way that makes it safely and sustainably usable for visitor movement without endangering the original substance and evoking its further loss.

As a first step, recently and sub-recently accumulated sediments were removed, and all fallen blocks uncovered and evaluated in situ for re-use. An archaeological investigation was not necessary, as the rubble did not extend into an archaeologically

relevant depth.²¹ Standing original parts of the wall were consolidated. During the in situ examination of the fallen blocks, portions of the wall were identified, which had collapsed en bloc and could be re-fitted in their original position. The blocks were then directly used in the reconstruction. On top of the wall portions which were originally preserved or re-fitted in original position, a slightly recessing intermediate layer of bricks was inserted, corresponding in height to the same respective layer of sandstone blocks. On top of this, blocks from the collapse uncovered in the excavations which had originally come from the wall, but whose exact original position could not be detected were inserted. Missing portions – including those where block material from the collapse had been removed undocumented during excavations of the 1960s – were filled with bricks. The work was finished with the complete plastering and a patina-like colouring of all wall portions executed in brick. The top of the restored wall was designed in an open, stepped way showing the two block shells and the filling blocks, in order to emphasize its character as

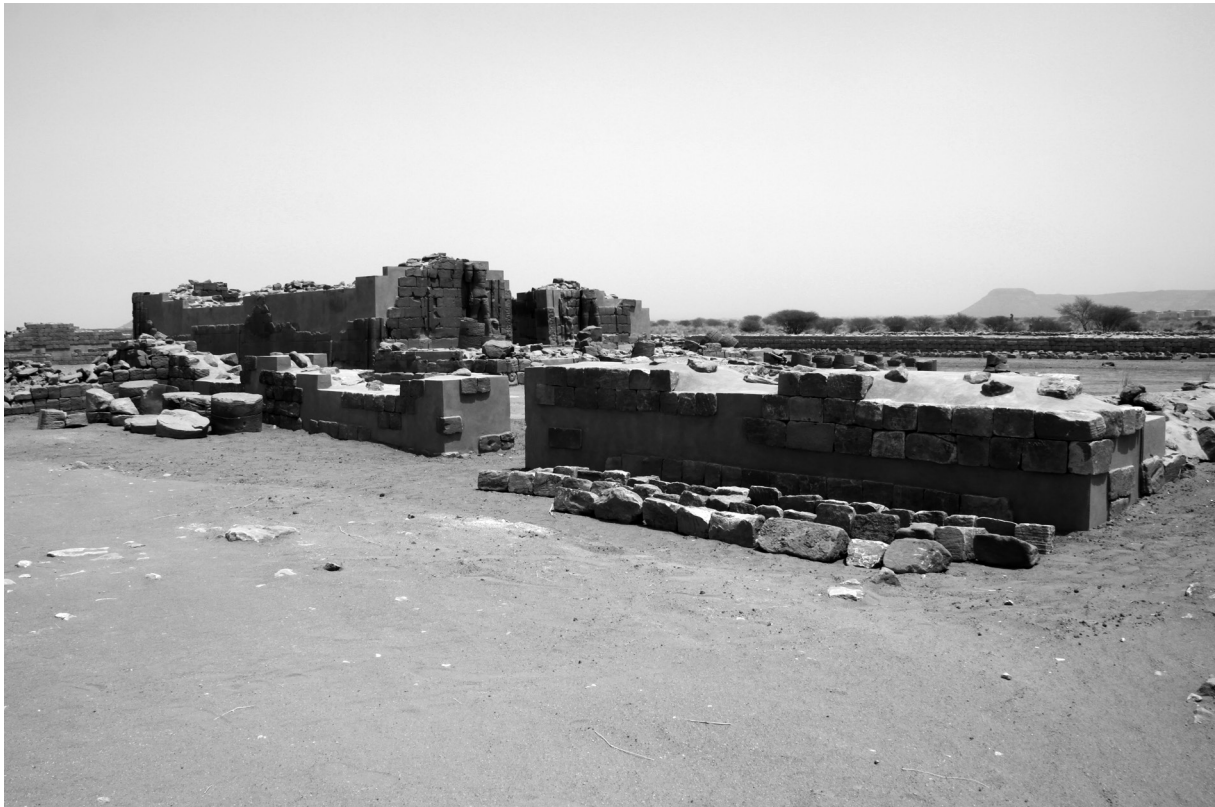
Fig. 12: Wall 117/304 with the gate towards courtyard 304 after reconstruction (photograph: Cornelia Kleinitz)

a restored ruin. The top was eventually sealed with coloured lime mortar. This approach marks the wall as a consolidated original wall, partly reconstructed, but not pretending to extend to its original height (fig. 12).

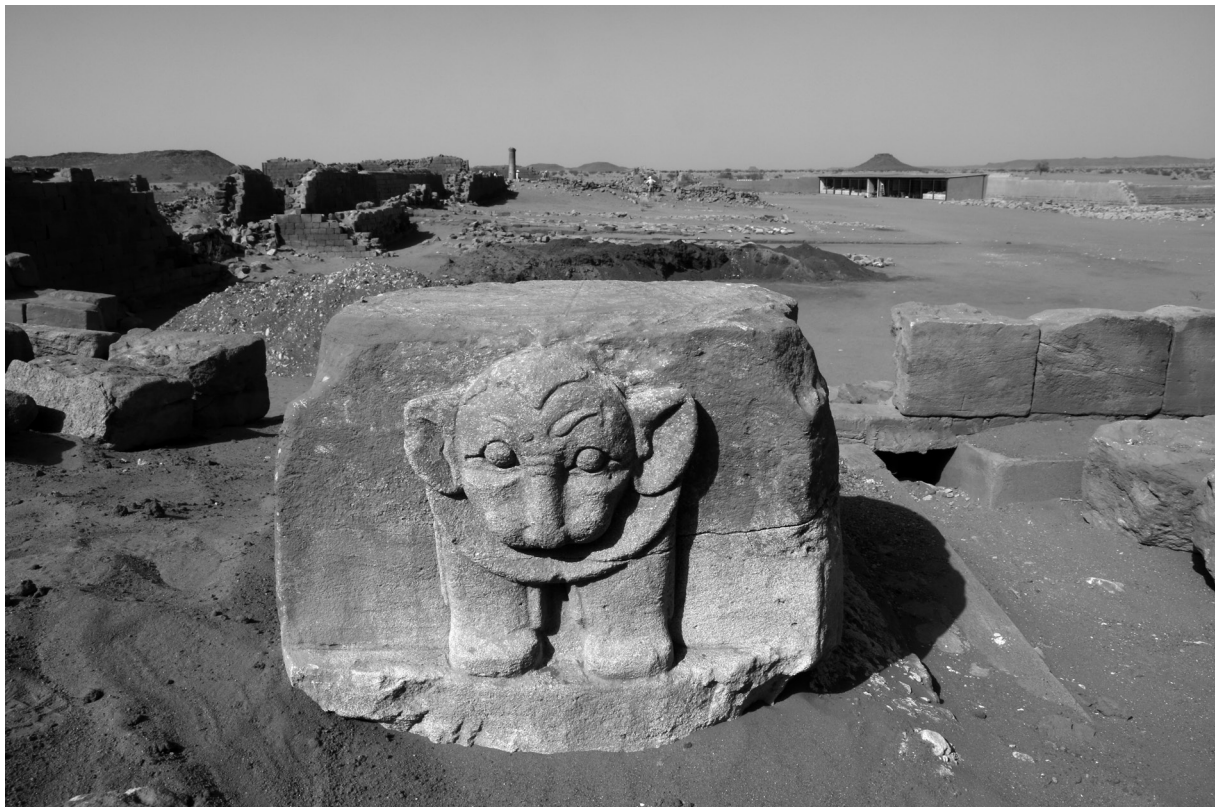
Fig. 13: The northern column base in room 108 after the removal of its temporary protective cover (photograph: Claudia Näser)

Within the realm of the conservation project, it was also decided to open the protective cover of one of the two column bases with figural decoration in room 108. This cover diverged in construction from the brick encasings in front of the Central Temple and it was deemed necessary to evaluate the state of preservation of the base and the effect which the sand filling of the cover had had on the object. The examination brought satisfactory results: after having been covered since the mid-1990s, the base was found to be in a good condition (fig. 13).

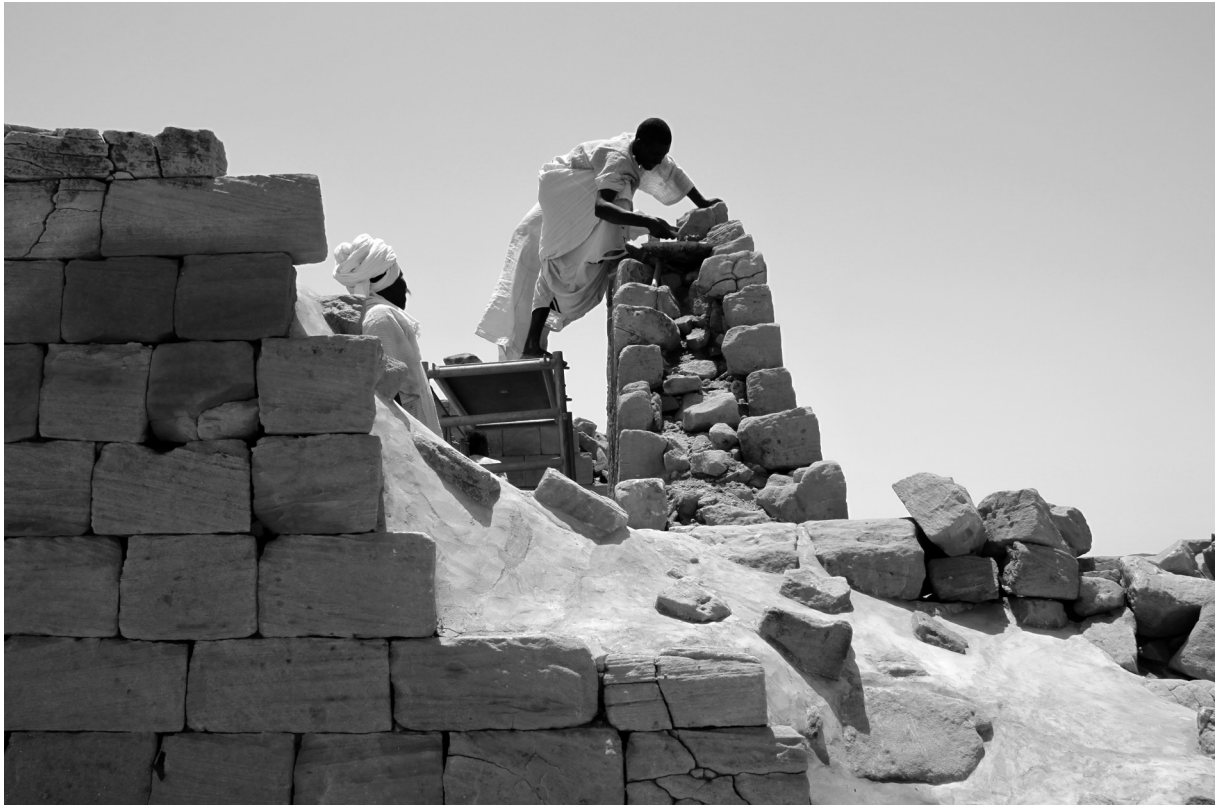
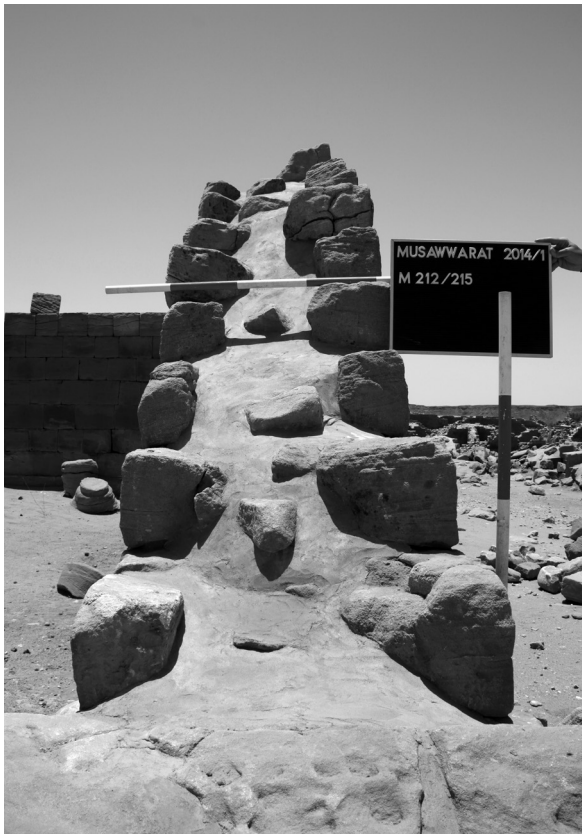
Fig. 14: Applying a lime mortar covering to an open wall top in Complex 200; in the foreground a wall top after treatment (photograph: Juliette Brauer and Franziska Lehmann)

Fig. 15: Wall 212/215 with the protective cover of lime mortar in place (photograph: Juliette Brauer and Franziska Lehmann)

is concerned with protecting the walls of the Great Enclosure from further deterioration by water seepage. Almost all of the walls of the Great Enclosure have lost their original capping, the so-called donkey-backs i.e. sandstone blocks with a triangular section that aids water run-off to the sides of the walls. Most walls with their two-shell masonry and core of sandstone rubble embedded in earth mortar are now open for intruding rain water which erodes the earth mortar of the filling and destabilises the walls. An effective measure against this deterioration is to seal the wall tops with a layer of lime mortar that is then painted to match the colour of the sandstone blocks. The lime mortar wall covers are applied without physical intervention into the existing portions of the walls, apart from some cleaning of the wall tops from loose rubble before the application of the mortar. The new wall covers are clearly differentiated from ancient material and their application is reversible. In the 2013/14 season work in this project concentrated on Complex 200 i.e. the buildings and courtyard walls surrounding Temple 200. Altogether, more than 100m of walls received a lime mortar cover (figs. 14–15).²⁷

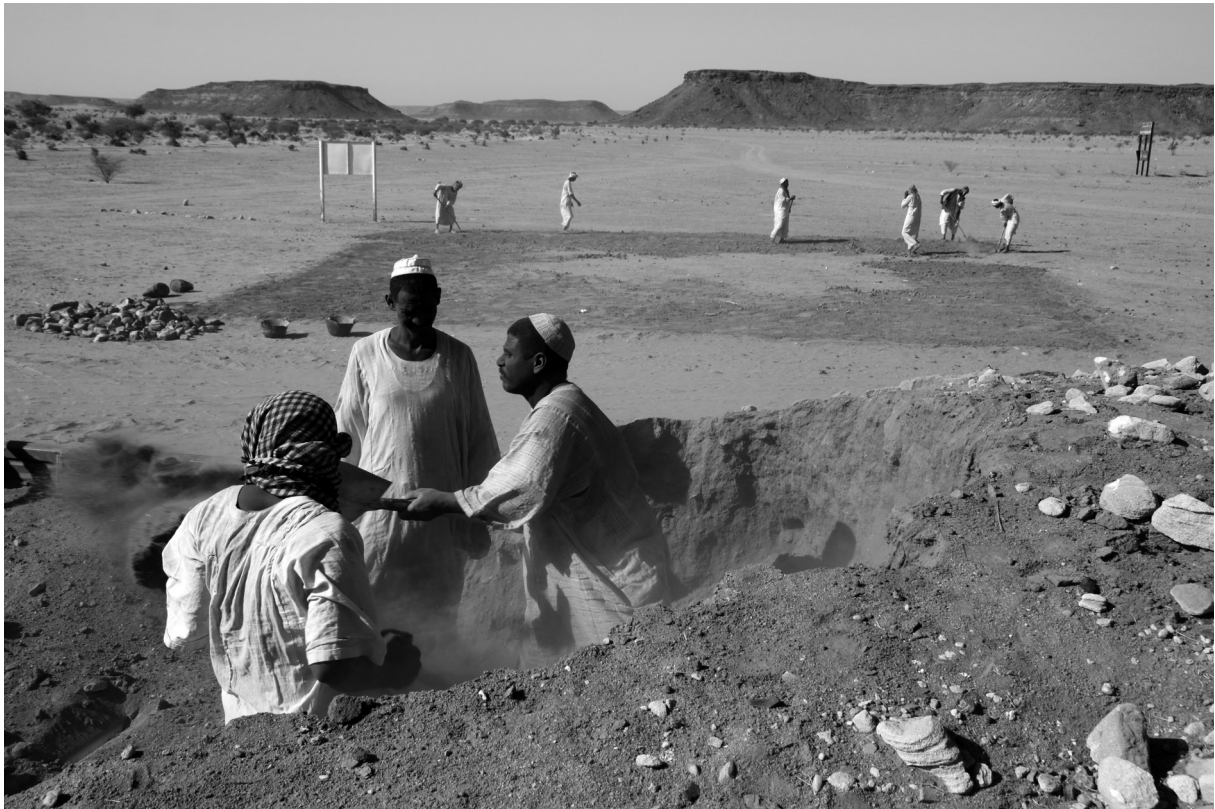
The area of the tourist police station, the first stop for visitors to Musawwarat, was cleared from building debris and other rubble, including the remains of an older square enclosure that had housed the first police checkpoint at the site (fig. 16). A new, low enclosure was constructed from bricks for the new police station (fig. 17). The visitor toilet was equipped with entrance gates that are hoped to prevent donkeys from invading the toilet area in search of shade. Additionally, repairs to the doors of individual toilet cubicles were undertaken and the floor of the building received a concrete cover. An installation by the tourist police at the Smallest Enclosure involving a pole and barrel for gaining a better telephone signal was removed.

Fig. 16: Re-designing the area of the tourist police station, including the removal of an unused enclosure of the first police checkpoint; in the foreground work at the kom of debris south of the Small Enclosure (photograph: Cornelia Kleinitz)

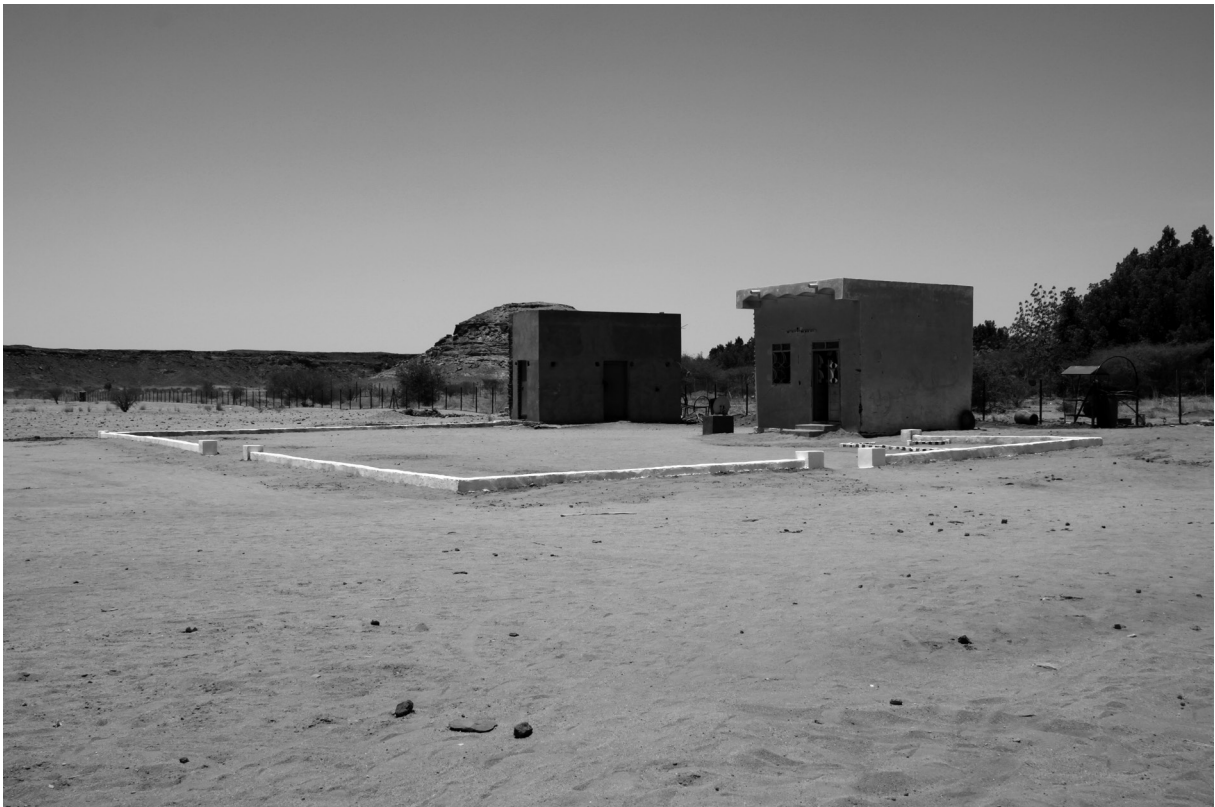
Fig. 17: The new enclosure at the police station (photograph: Cornelia Kleinitz)

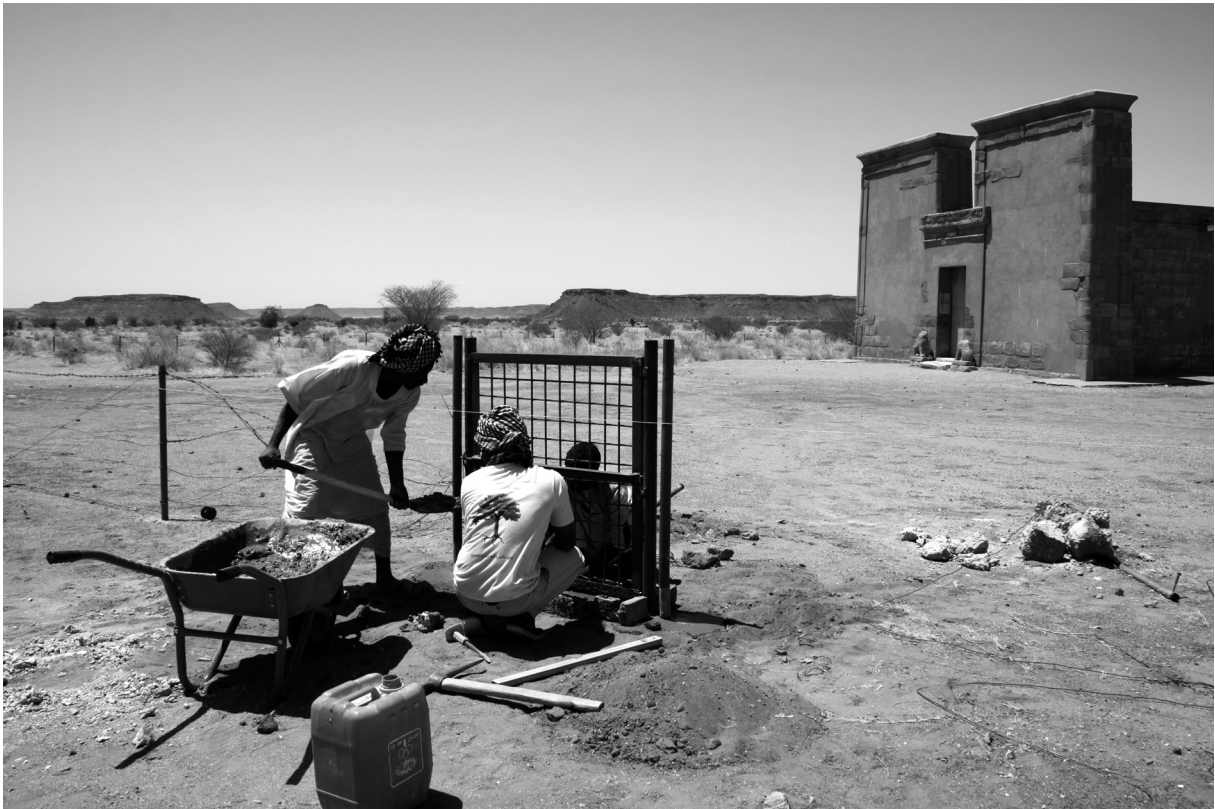
Fig. 18: Installing the new gate in the fence of the Lion Temple (photograph: Cornelia Kleinitz)

The first measures in the rehabilitation of the Lion Temple in the 2013/14 season comprised in the construction of a new entrance gate at the customary car park area northeast of the temple, the repair and closure of the old gate, the partial consolidation of the fence surrounding the temple, the removal of accumulated sand from the entrance area, the closure of water gullies and the removal of the defunct explanatory sign (fig. 18).³⁶

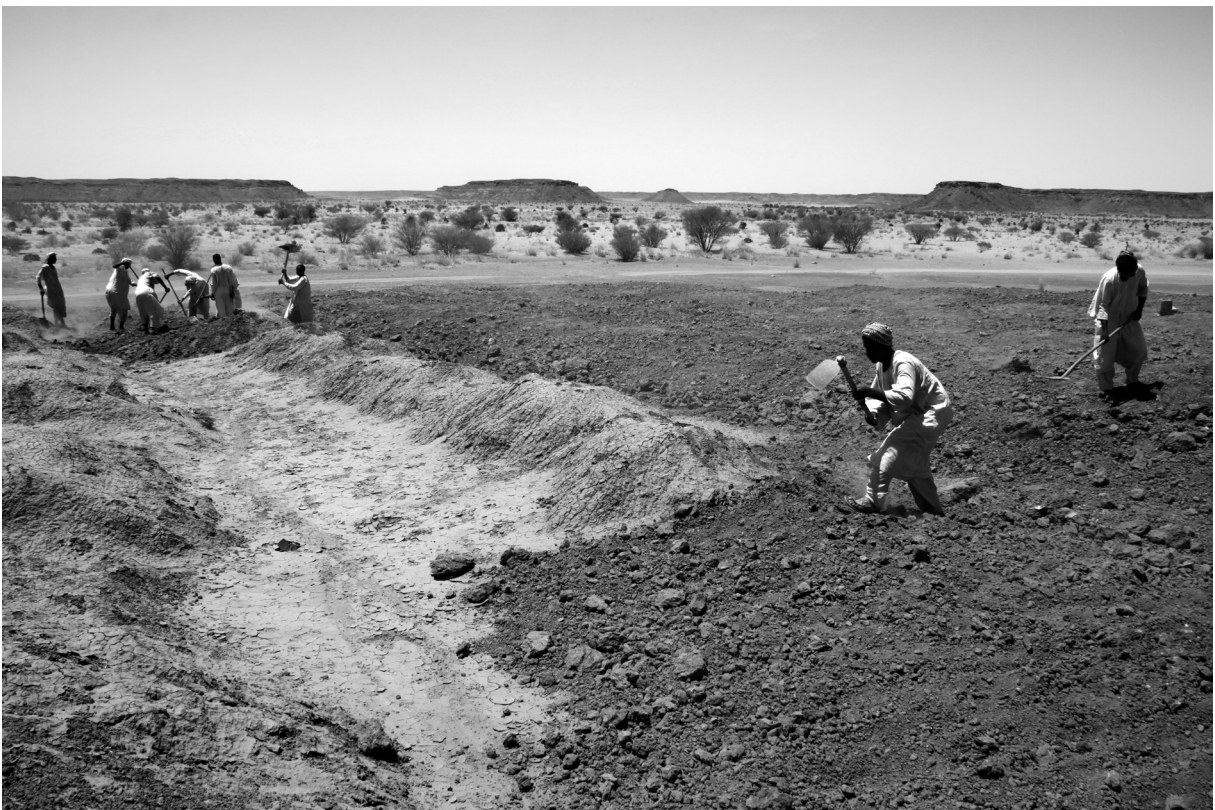
Fig. 19: Flattening heaps of modern debris from the excavations in the Great Hafir by the Sudan Civilization Institute in the mid-2000s (photograph: Cornelia Kleinitz)

As an initial measure alleviating the extreme visual intrusion into the site caused by hundreds of lorry loads of hafir deposit that were removed from the monument and deposited along its flanks upon initiative of the Sudan Civilization Institute in the mid-2000s,³⁸ two stretches of heaps in the immediate proximity of the Lion Temple were flattened (fig. 19). This measure sped up the process of the deflation of the mounds, which would have naturally resulted in a similar situation within several decades due to water runoff. The measure has partially re-established the view-sheds from the Lion Temple to the hafir, and from the top of the hafir to the Lion Temple, as they existed before the intervention of the Sudan Civilization Institute. It is clearer now to the observer, which mounds are part of the wall structure of the ancient monument and which are a result of the recent re-digging of the Great Hafir.
