CLAUDIA NÄSER

SITE MANAGEMENT AT MUSAWWARAT ES-SUFRA 2014/15: CONCEPTS, MEASURES AND PERSPECTIVES

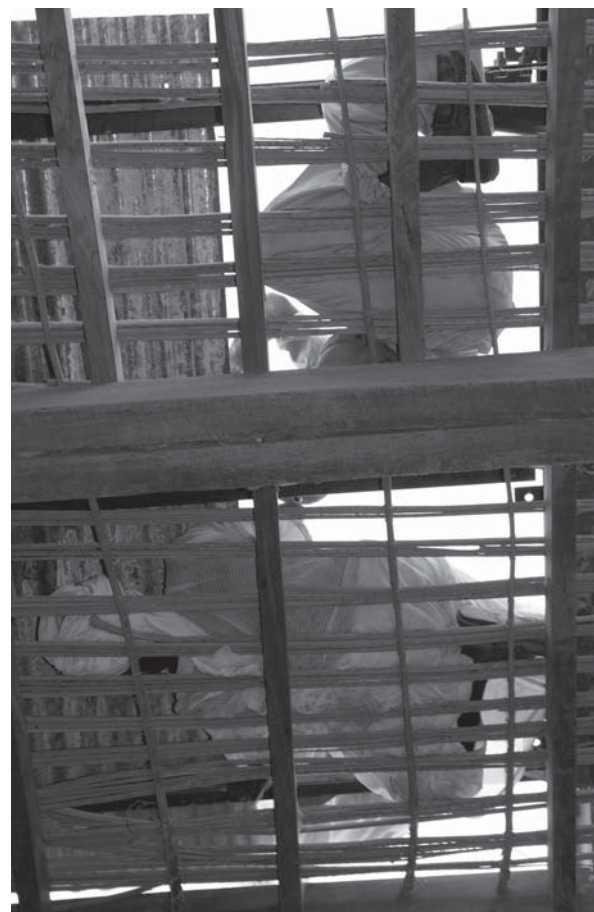
The ‘autopsy’ confirmed that the original tin roof of 1970, whose multiple cracks and open joints allowed moisture to penetrate into the wall tops, was beyond repair. The original steel subconstruction was assessed with regard to static’s requirement and its condition. It was judged to be adequately dimensioned and completely intact, with no interventions or replacements being necessary. The only exception was the six bearings of the subconstruction which had been cemented into the temple walls and which needed to be replaced by slide bearings as the inflexible construction of the original bearings resulted in friction from the wind load impinging on the roof and transferring into the masonry. This in turn led to the enlargement of cracks in the relief temple walls under the bearings.

Fig. 3: Preparing the roof of the Lion Temple for investigation, October 2014 (photo: Claudia Näser)

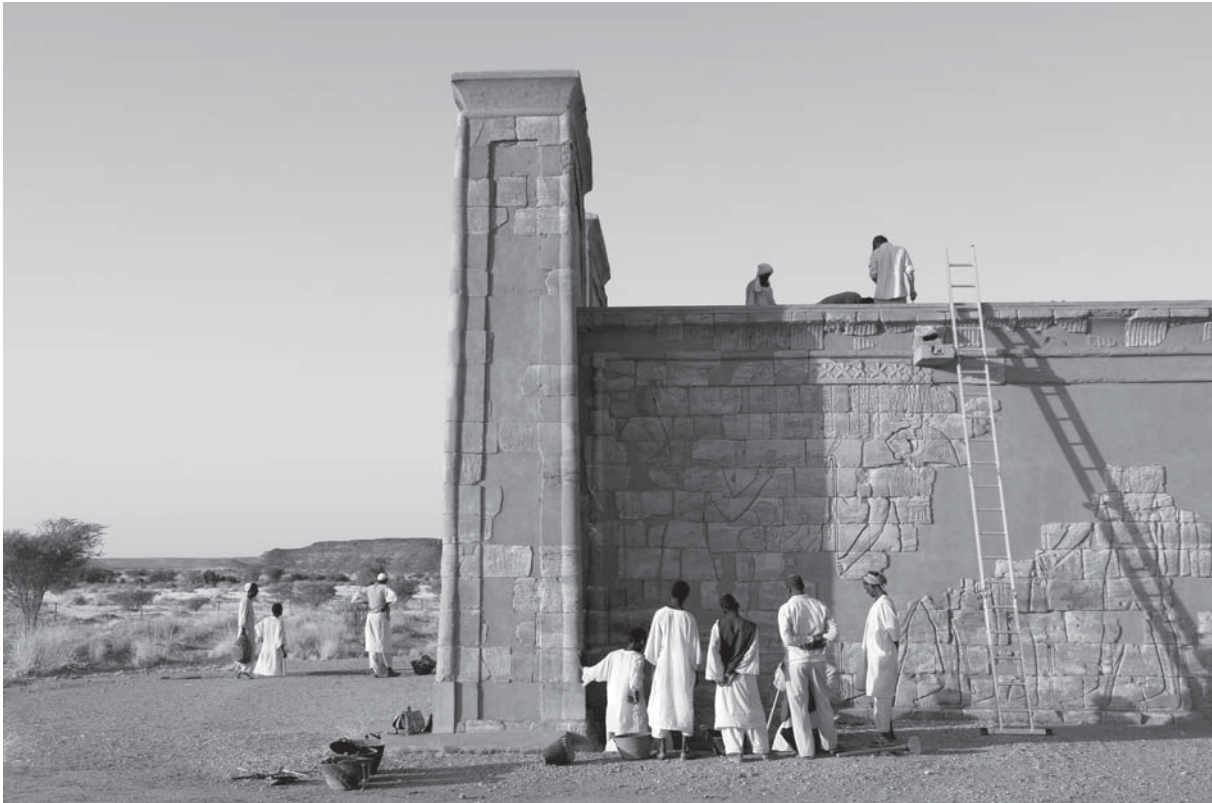
Fig. 4: Excavations at the southern and northern pylon towers of the Lion Temple, October 2014 (photo: Claudia Näser)

The comprehensive investigation of the potential causes of these cracks was continued with excavations in the area of the temple's two pylon towers (figs. 4–5).¹⁰ The findings showed that the cracks had not been caused primarily by the inadequate roof bearings – although they negatively impacted them –, but by an accelerated dehydration of the mighty unreinforced concrete body which underlies the reinforced concrete foundations of the temple proper (fig. 5). This dehydration had prevented the proper setting of the concrete body, resulting in an increased porosity of its outer shell, which then led to a localised settlement of the standing walls in the pylon area and the cracks between the front and the rear part of the temple. The investigation also showed that while the cracks do not impair the static of the building or any of its parts in any way, they cannot be effectively removed as they continue into the lowest part of the tripartite foundation construction, namely the unreinforced concrete body. As an aesthetically adequate handling, the insertion of deliberate expansion joints has been suggested and will be implemented within the upcoming project dedicated to the conservation of the temple's relief walls and the re-plastering of its reconstructed wall sections.

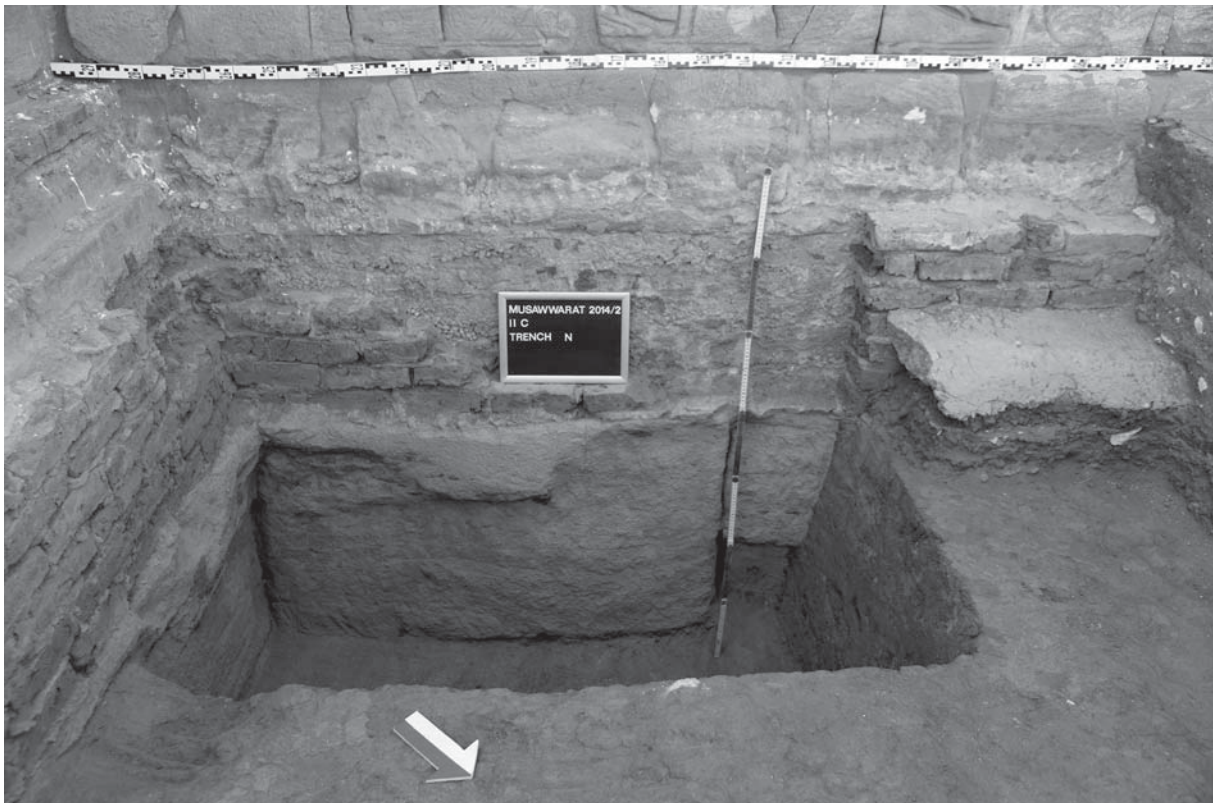
Fig. 5: The foundations of the reconstructed Lion Temple consisting of a mighty unreinforced concrete body underneath the actual reinforced concrete foundations, the brick-lining of which has been supported by a concrete 'shirt' (preserved on the right side), exposed in the trench in the rear of the northern pylon tower (photo: Claudia Näser)

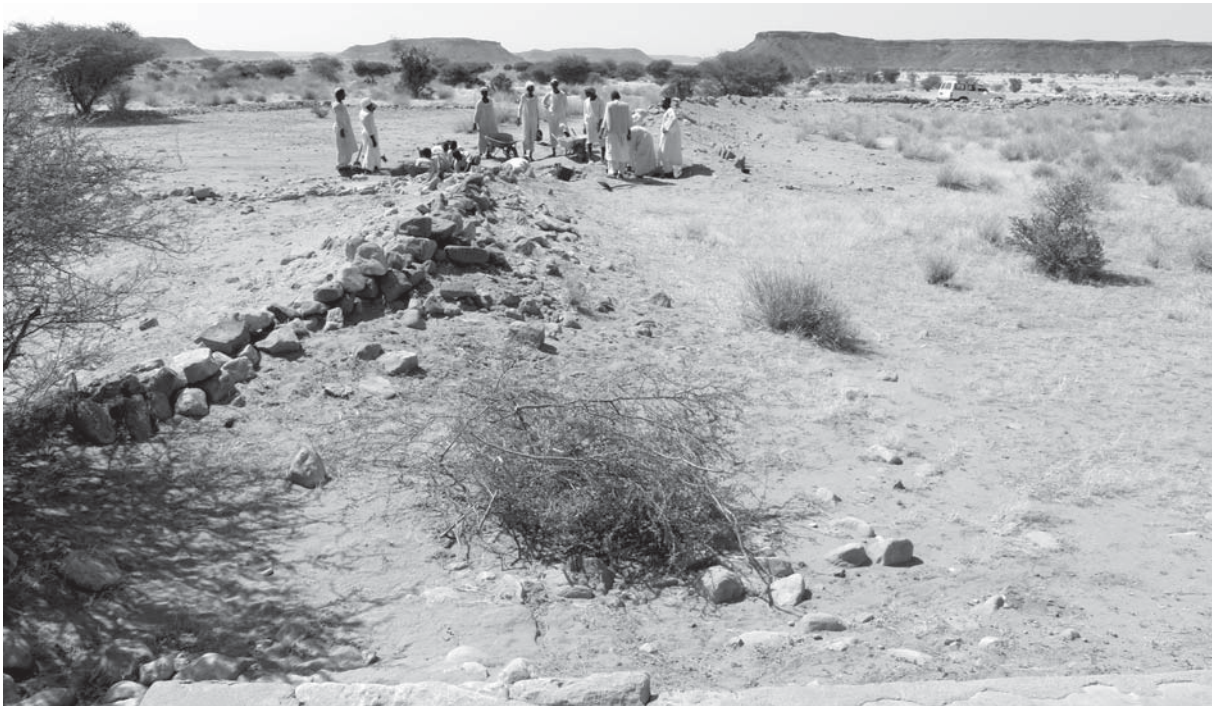
Fig. 7: The embankment of excavation debris delineating courtyard 415 towards southeast (photo: Claudia Näser)

excavation rubble stretching from the preserved corners of walls 415/E and 415/S, thus forming an arbitrary border of courtyard 415 (figs. 1, 7). Visually dominating, this embankment conveyed the feeling that it outlined the original courtyard wall despite the fact that it ran up to 20m west of it.

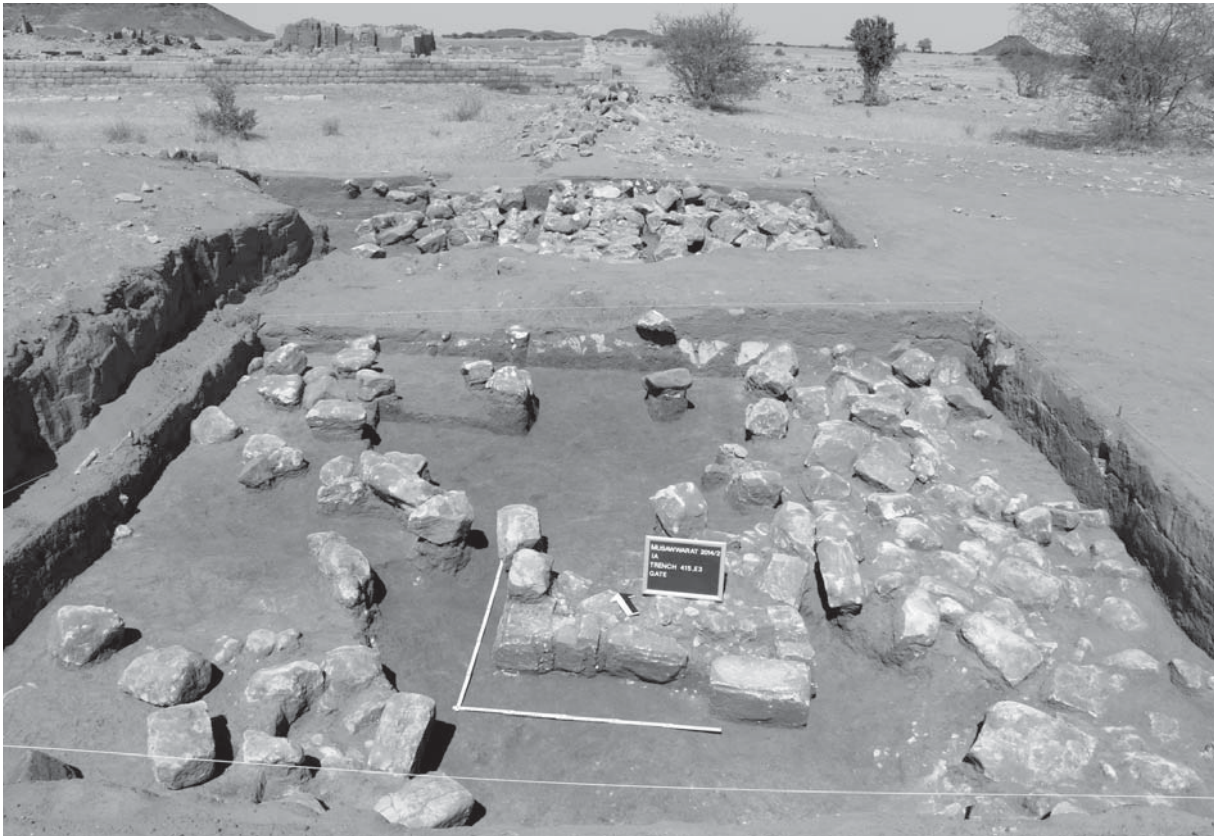
Fig. 9: The newly discovered entrance gate into the Great Enclosure, 415-E, in trench 415.E3 from the south (photo: Claudia Näser)

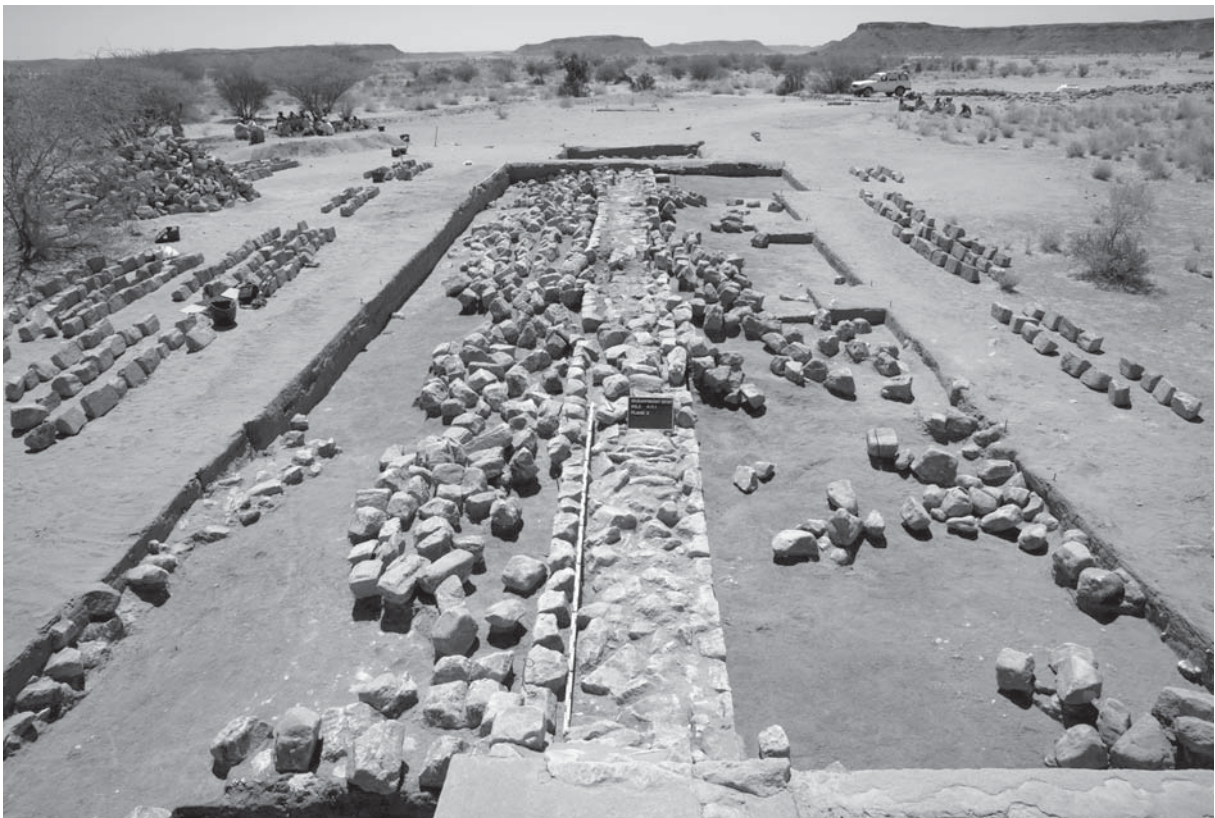
the 1960s. In addition, up to six layers of *en bloc* wall collapse were revealed (figs. 10–11) which had the potential to be reassembled in their original position. With these findings, more than 20m of the ancient enclosure wall and a hitherto unknown entrance gate were regained.

Fig. 10: Trenches 415.E4, 5, 6, 7, 1 (after documentation and removal of bulks) and 415.E3 in the south with the recovered segment of the enclosure wall 415/E (photo: Claudia Näser)

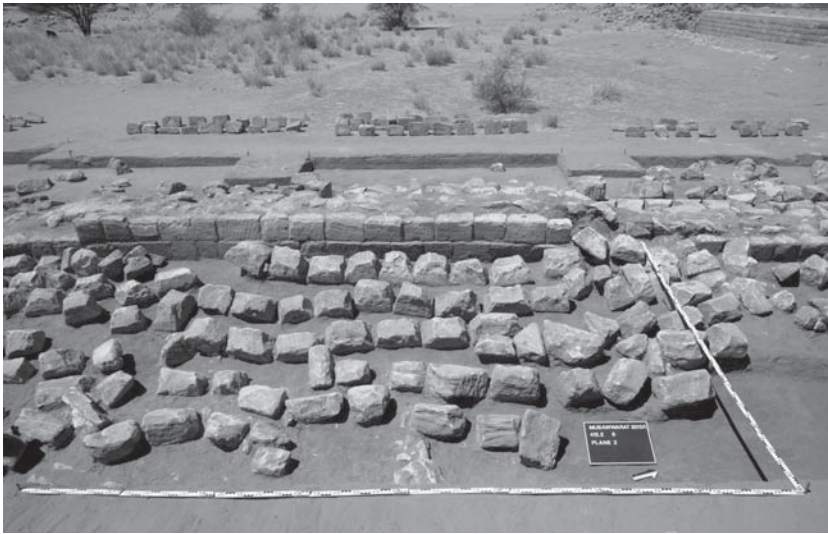
Fig. 11: Trench 415.E6 with up to two layers of the wall 415/E *in situ* and up to six layers of *en bloc* block collapse (photo: Claudia Näser)

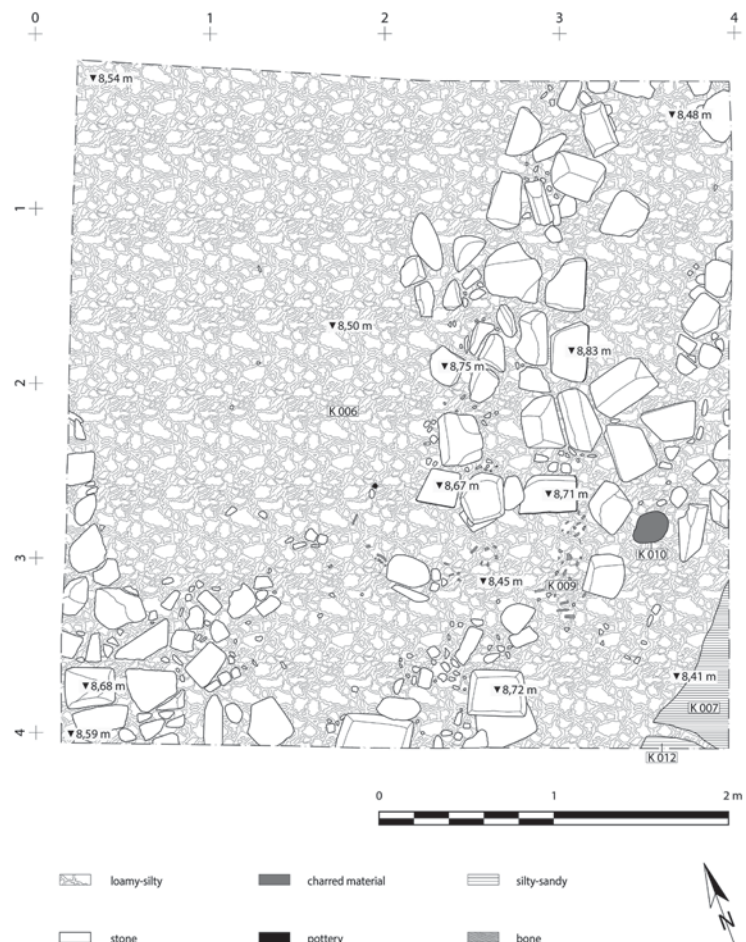
Finally, the remains of the abovementioned ‘missing’ corner of the enclosure, i.e. the southeastern corner of courtyard 415, were also detected. The reopened trench 415.S4 (fig. 8) produced a substantial layer of wall collapse, starting from the local height of 8.93m, going down up to about 8.5m (fig. 12).

While the stratigraphic record and a considerable spread of blocks towards the south and east, i.e. the direction of the wadi, proved heavy fluvial activities, the trench also revealed a corner situation with an actual corner block almost in alignment with the reconstructed north-south course of wall 415/E (fig. 12).

Fig. 12: The lowest layer of wall collapse in Trench 415.S4 with the supposed corner indicated in bold lines (drawing: Claudia Näser)

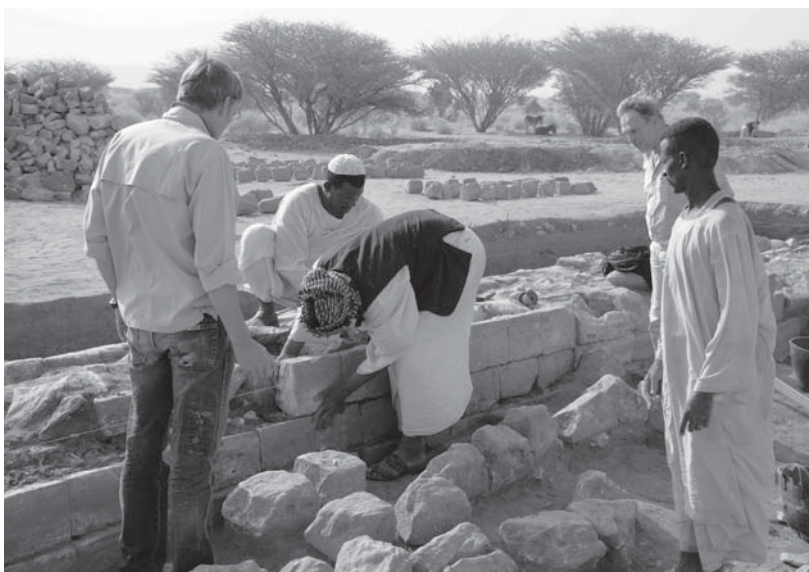
Fig. 13: Reconstruction of wall 415/E (photo: Claudia Näser)

After the excavation had been completed, the reconstruction of wall 415/E started (fig. 13), following the concept established in the previous years.¹⁵ By the end of the season, the wall was reconstructed over a course of almost 20m up to six courses high. The remaining parts will be finished in the upcoming project year.

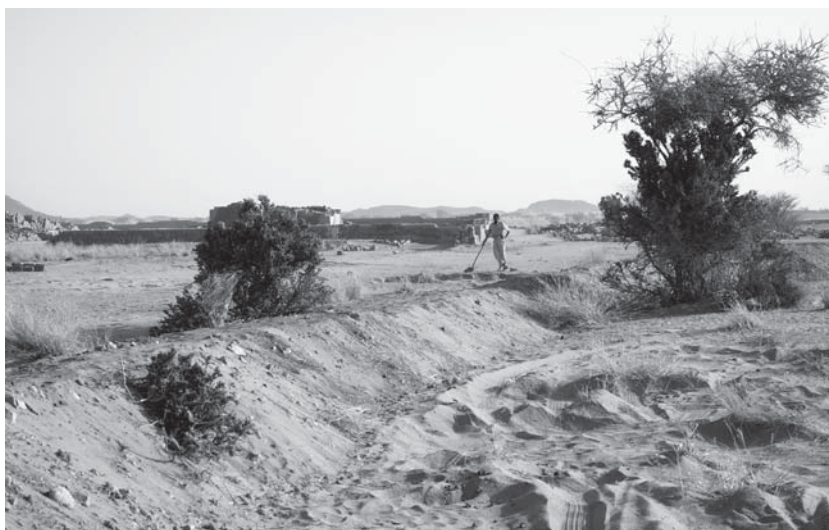
Fig. 14: The southwards extension of the protective wall towards the wadi east of the Great Enclosure (photo: Claudia Näser)

precipitation. Simultaneously, the protective rubble and sediment platform which had been constructed east of the Great Enclosure in spring 2014 to prevent the flooding of this area by surface runoff, and the low camouflaged stone wall which secured this platform towards the wadi¹⁶ were extended more than 40m towards the south (figs. 1, 14) to consolidate and eventually enlarge the access area with the parking lot south of the Great Enclosure for future development.

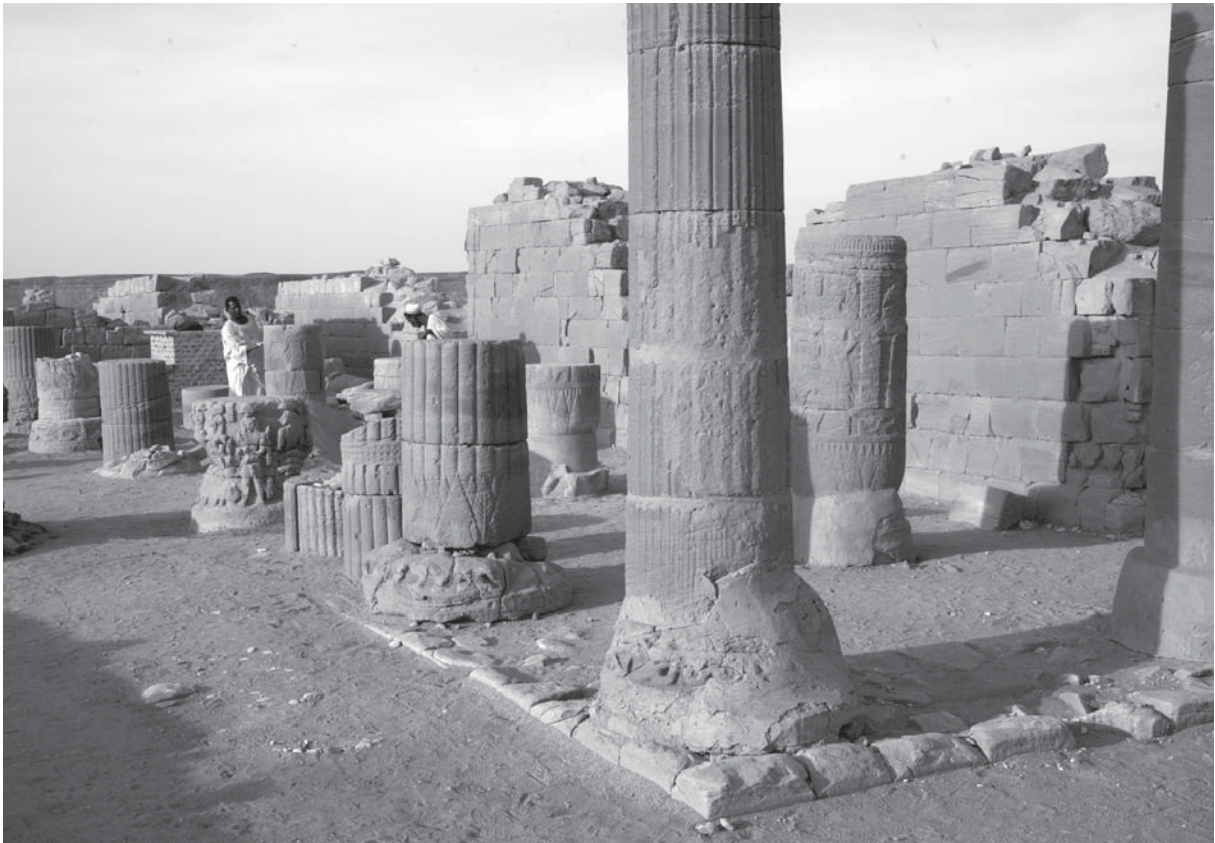
Fig. 17: The columns in front of Temple 100 with their protective encasings temporarily removed during the conservation survey; note the restored column 8 in the rear row (photo: Claudia Näser)

With the insights from column 8, a detailed condition assessment and work schedule for the treatment of the other seven columns, plus two additional columns of the outer peripteros circle, were prepared in the spring season 2015. This survey included an identification and detailed autopsy of all existing column fragments *in situ* (fig. 17), in the on-site museum and in the temporary stone repositories at the site. A detailed report of the findings and the resulting operational programme was drafted, and its implementation will continue with measures to consolidate the stone substance of the columns in autumn 2015. For the time being, all pieces on the Central Terrace, with the exception of the newly conserved parts of column 8, have once again been secured by protective brick encasings.

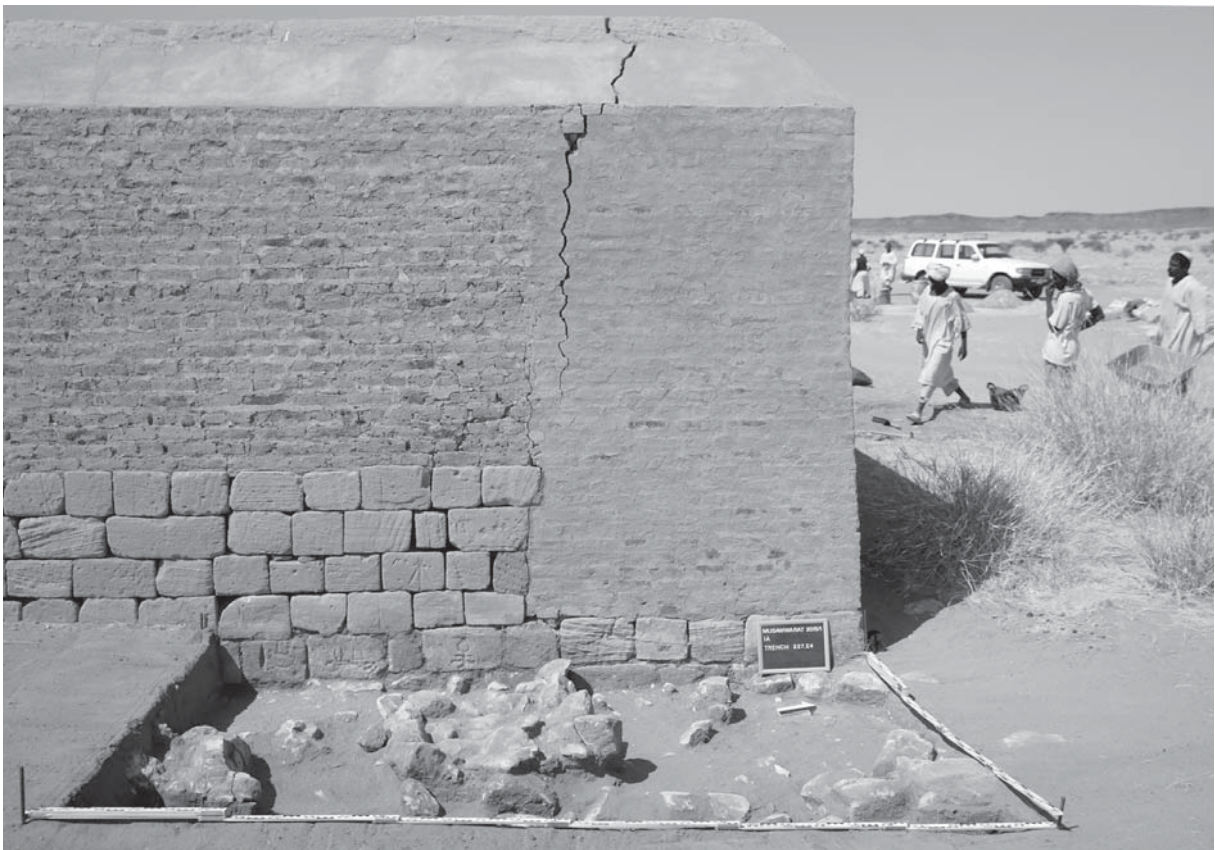
Fig. 18: Crack in the reconstructed enclosure wall at the northeastern corner of the Great Enclosure (photo: Claudia Näser)

Reconstruction of the outer wall of the Great Enclosure started in 1997. In 1998 its northeastern corner (fig. 8: 227/N+E) was re-erected, and in the following year the rebuilding was continued towards south.²⁴ Recently, a crack had developed at the inadequately formed joint between the 1998 and 1999 segments (fig. 18), primarily due to the settlement of the 1998 portion. This settlement was in turn provoked by rain water accumulations and fluvial erosion brought about by the uncontrolled outlet of the drainage from the site museum. Two mitigation measures were implemented. First, the drainage of the museum was shifted into a new outlet channel (fig. 19) which runs into a newly built infiltration well north of the enclosure wall (fig. 20). This well has a diameter of 1.8m and a depth of c. 3m, and is filled with brick rubble, covered with a plastic sheet and a layer of earth. After the cause for the settling had thus been remedied, the enclosure wall around the crack was taken down and re-built with a deliberate expansion joint (figs. 19, 21).

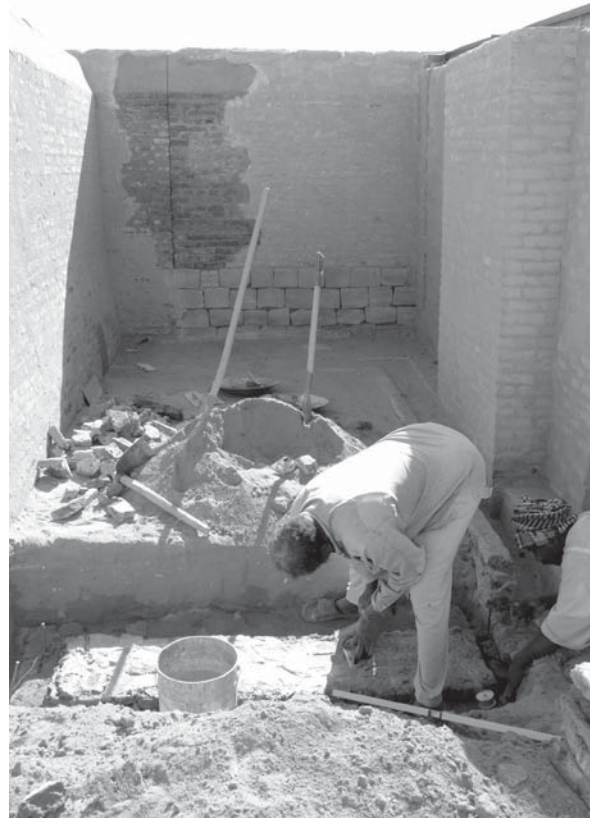
Fig. 19: Construction of the new outlet channel for the drainage of the site museum; note the re-modeled, though still unplastered area of the crack in the enclosure wall in the rear (photo: Claudia Näser)

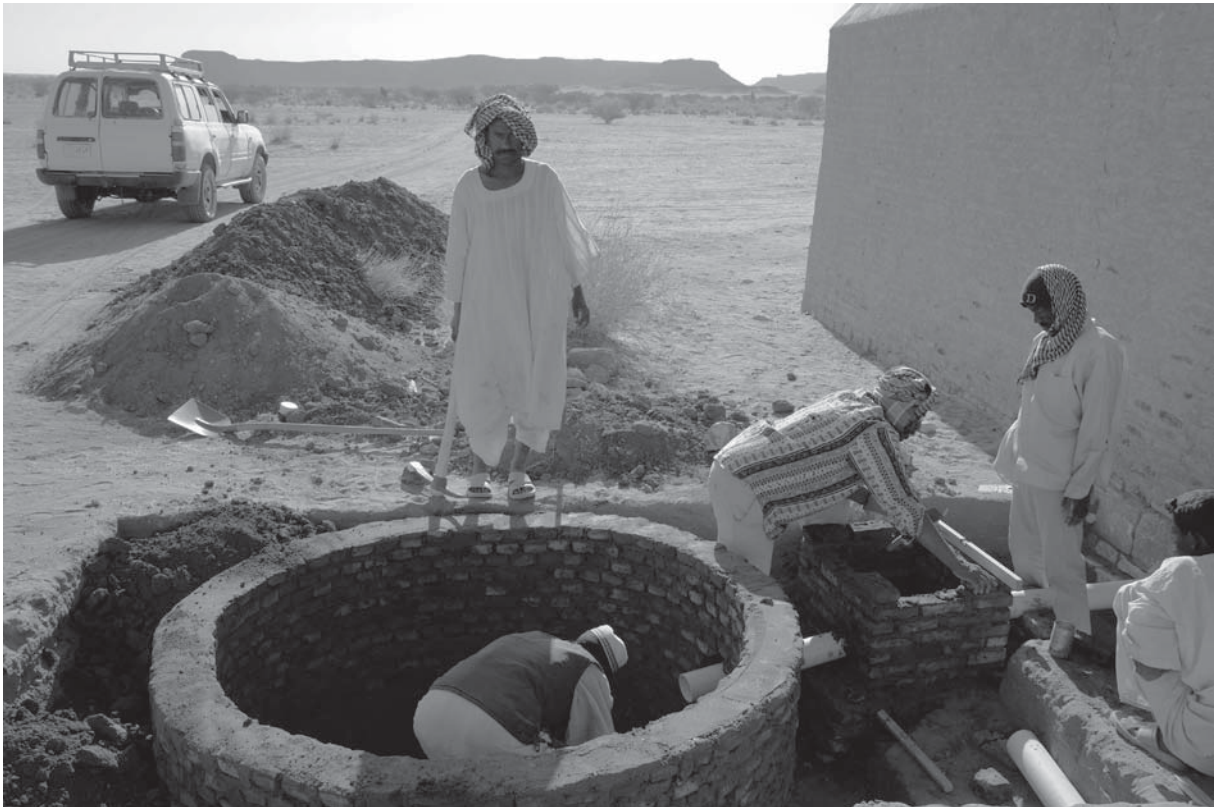
Fig. 20: Construction of the infiltration well outside the enclosure wall (photo: Claudia Näser)

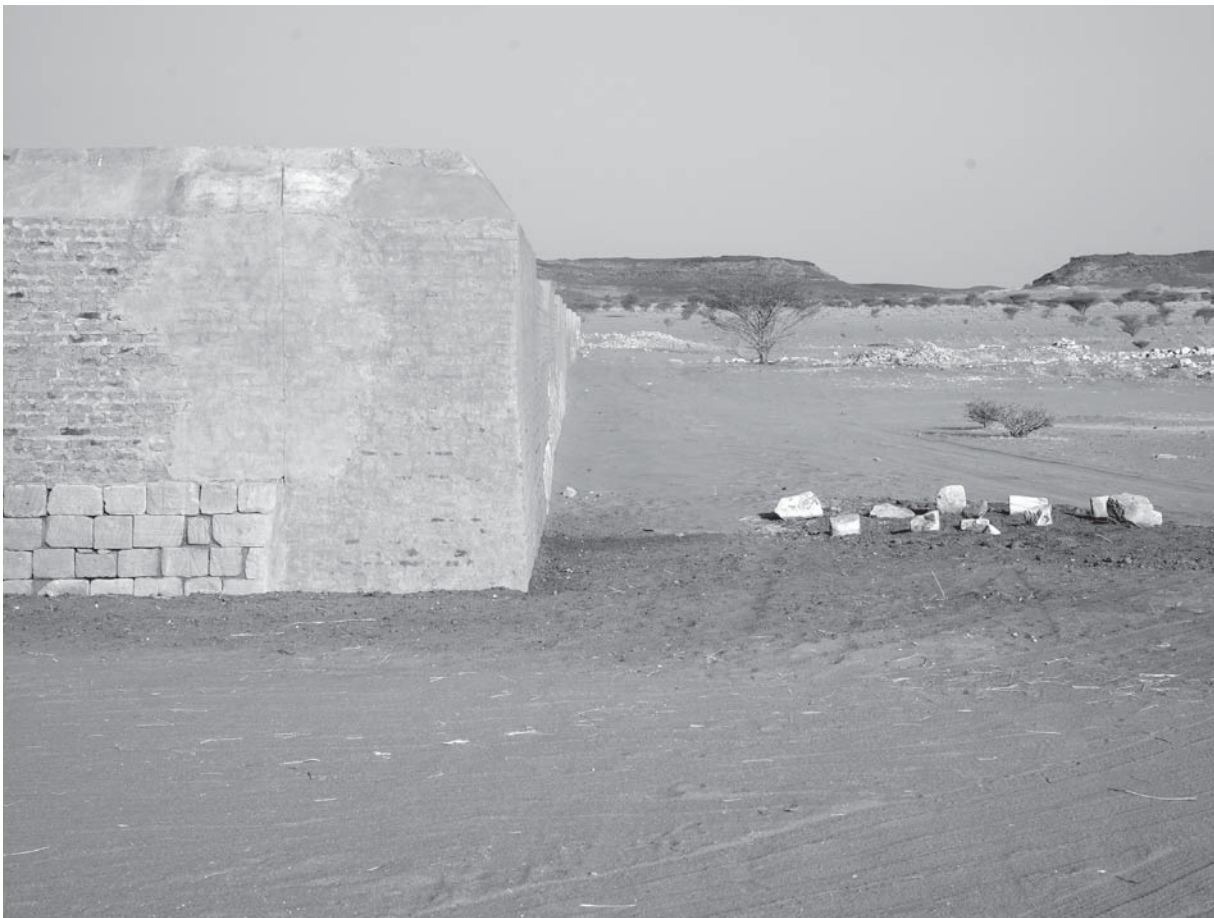
Fig. 21: The northeastern corner of the Great Enclosure after the completion of the measure (photo: Claudia Näser)

in the rehabilitation of this part of the site (fig. 21), which will be continued in connection with the construction of the fence in the coming project year. The material from these clearings was also used in the extension of the platform southeast of the Great Enclosure (cf. above p. 15).

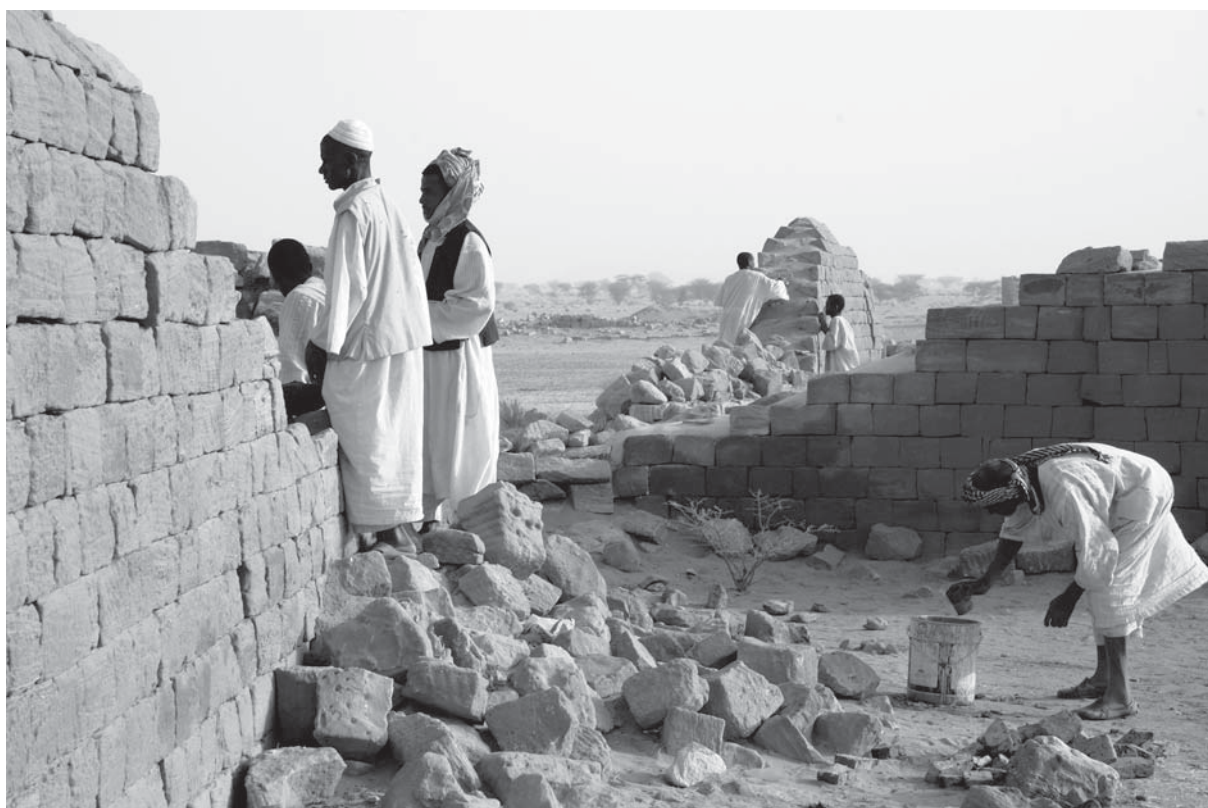
Fig. 22: Covering open wall tops with a lime mortar capping in Complex 500; in the centre and the background walls after treatment (photo: Claudia Näser)

rain water which erodes the earth mortar of their filling and as a consequence also destabilises the outer masonry shells. An effective measure against their deterioration and eventual collapse has been found by sealing the open wall tops with a layer of lime mortar (fig. 22). The technique of this application has been developed and advanced over nearly two decades, meeting all standards required for such measures. The mortar covers are applied without a physical intervention into the existing structure of the walls. They are clearly differentiated from the ancient substance and completely reversible. Coloured in a sandy tone matching the surrounding sandstone building material they avoid any visual intrusion into the overall appearance of the site.

In spring 2015, lime mortar capping concentrated on Complexes 200 and 500 of the Great Enclosure i.e. the buildings and courtyards surrounding Temple 200 and north of the Central Terrace (figs. 8, 22). Altogether, 190m of walls received a cover. Photographs were taken of all walls prior to their treatment in order to facilitate condition assessments and future monitoring.
