CLAUDIA NÄSER

## SITE MANAGEMENT AT MUSAWWARAT ES-SUFRA 2014/15: CONCEPTS, MEASURES AND PERSPECTIVES

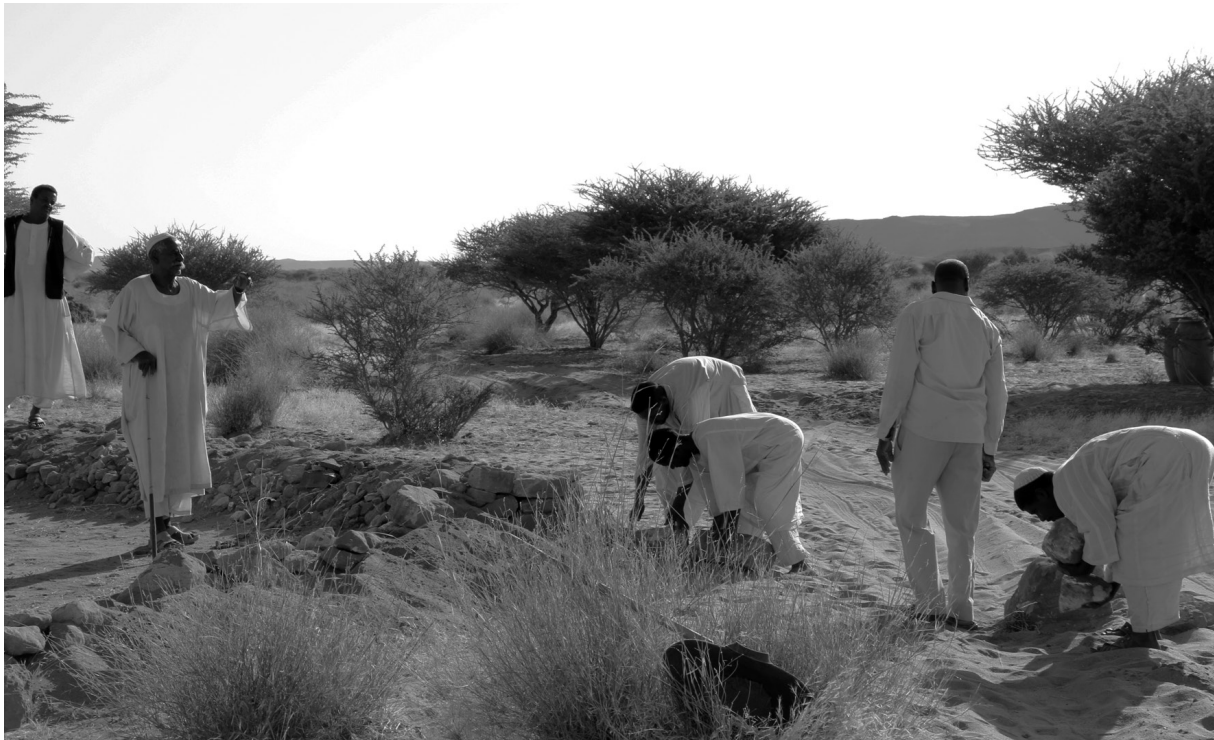
Fig. 2: Blocking the old track towards the Lion Temple under the supervision of Sheikh Mohamed Ahmed al-Dali, in the left part of the image (photo: Claudia Näser)

The first measure of the autumn season 2014 was to relocate the track from the Great Enclosure to the Lion Temple as part of the effort to reorganise the access to the main monuments of the site (figs. 1–2). This measure freed a considerable space at the southeastern corner of the Great Enclosure where the redesign of the main entrance towards the monument is to unfold. The old route to the Lion Temple was blocked and the proposed new route further south prospected so as to make sure that no hitherto unknown archaeological sites would be compromised. After these preparatory measures, the new route was prepared and levelled by manual

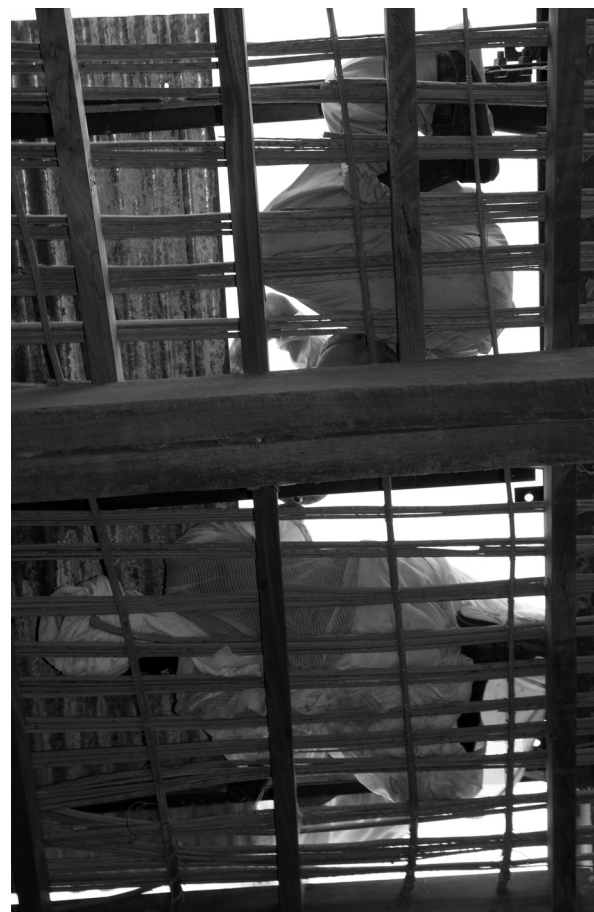
Fig. 3: Preparing the roof of the Lion Temple for investigation, October 2014 (photo: Claudia Näser)

The ‘autopsy’ confirmed that the original tin roof of 1970, whose multiple cracks and open joints allowed moisture to penetrate into the wall tops, was beyond repair. The original steel subconstruction was assessed with regard to static’s requirement and its condition. It was judged to be adequately dimensioned and completely intact, with no interventions or replacements being necessary. The only exception was the six bearings of the subconstruction which had been cemented into the temple walls and which needed to be replaced by slide bearings as the inflexible construction of the original bearings resulted in friction from the wind load impinging on the roof and transferring into the masonry. This in turn led to the enlargement of cracks in the relief temple walls under the bearings.

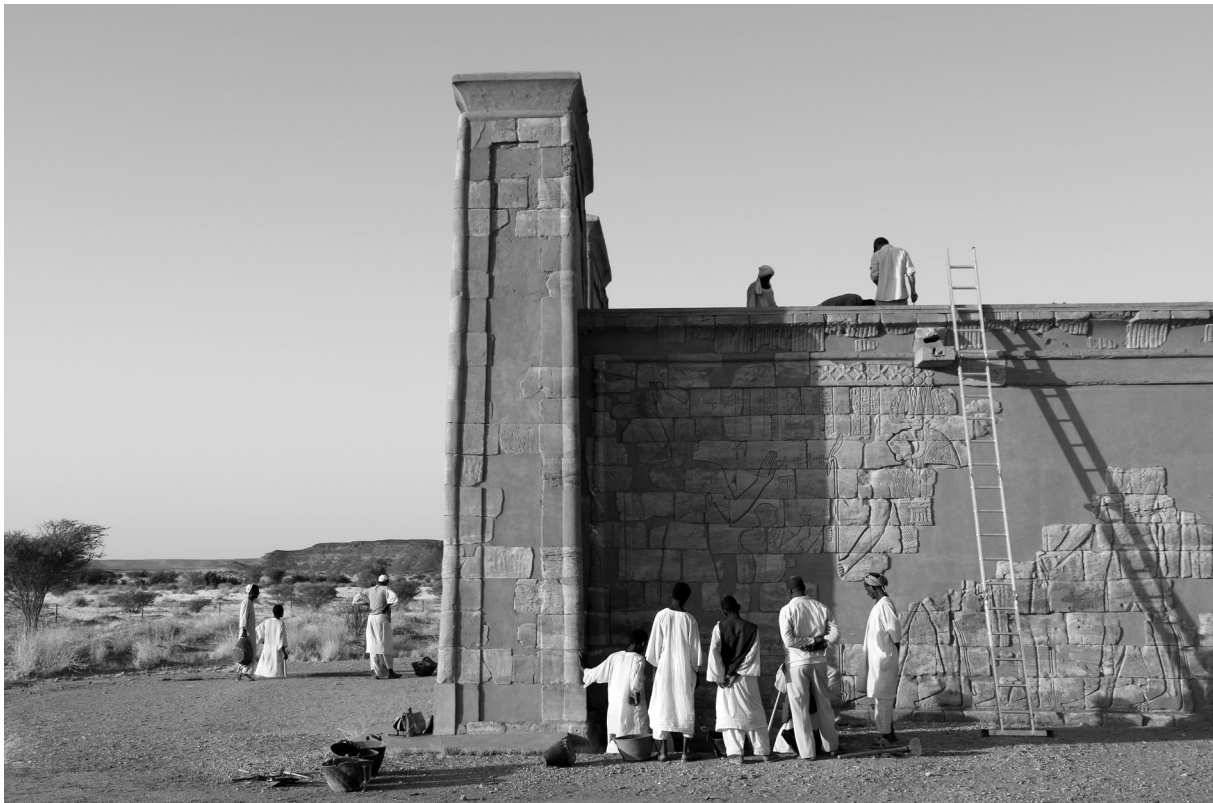
Fig. 4: Excavations at the southern and northern pylon towers of the Lion Temple, October 2014 (photo: Claudia Näser)

The comprehensive investigation of the potential causes of these cracks was continued with excavations in the area of the temple's two pylon towers (figs. 4–5).<sup>10</sup> The findings showed that the cracks had not been caused primarily by the inadequate roof bearings – although they negatively impacted them –, but by an accelerated dehydration of the mighty unreinforced concrete body which underlies the reinforced concrete foundations of the temple proper (fig. 5). This dehydration had prevented the proper setting of the concrete body, resulting in an increased porosity of its outer shell, which then led to a localised settlement of the standing walls in the pylon area and the cracks between the front and the rear part of the temple. The investigation also showed that while the cracks do not impair the static of the building or any of its parts in any way, they cannot be effectively removed as they continue into the lowest part of the tripartite foundation construction, namely the unreinforced concrete body. As an aesthetically adequate handling, the insertion of deliberate expansion joints has been suggested and will be implemented within the upcoming project dedicated to the conservation of the temple's relief walls and the re-plastering of its reconstructed wall sections.

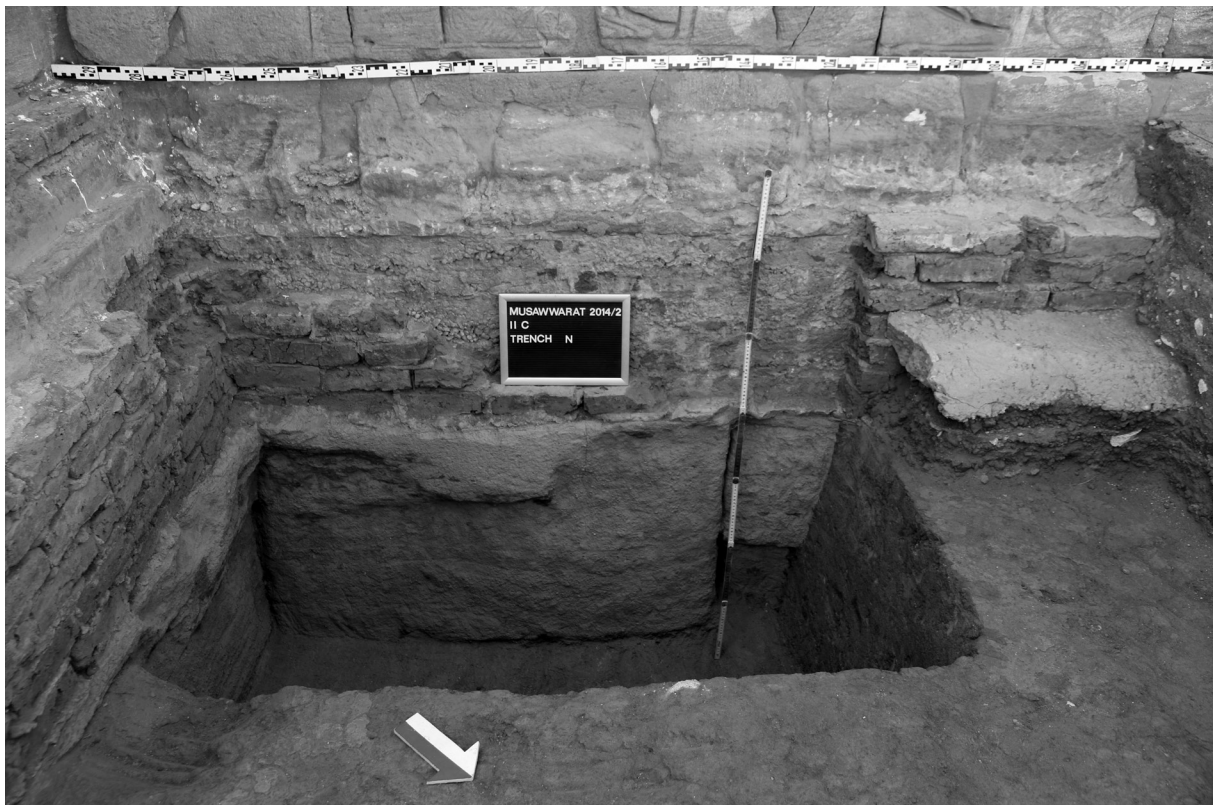
Fig. 5: The foundations of the reconstructed Lion Temple consisting of a mighty unreinforced concrete body underneath the actual reinforced concrete foundations, the brick-lining of which has been supported by a concrete ‘shirt’ (preserved on the right side), exposed in the trench in the rear of the northern pylon tower (photo: Claudia Näser)

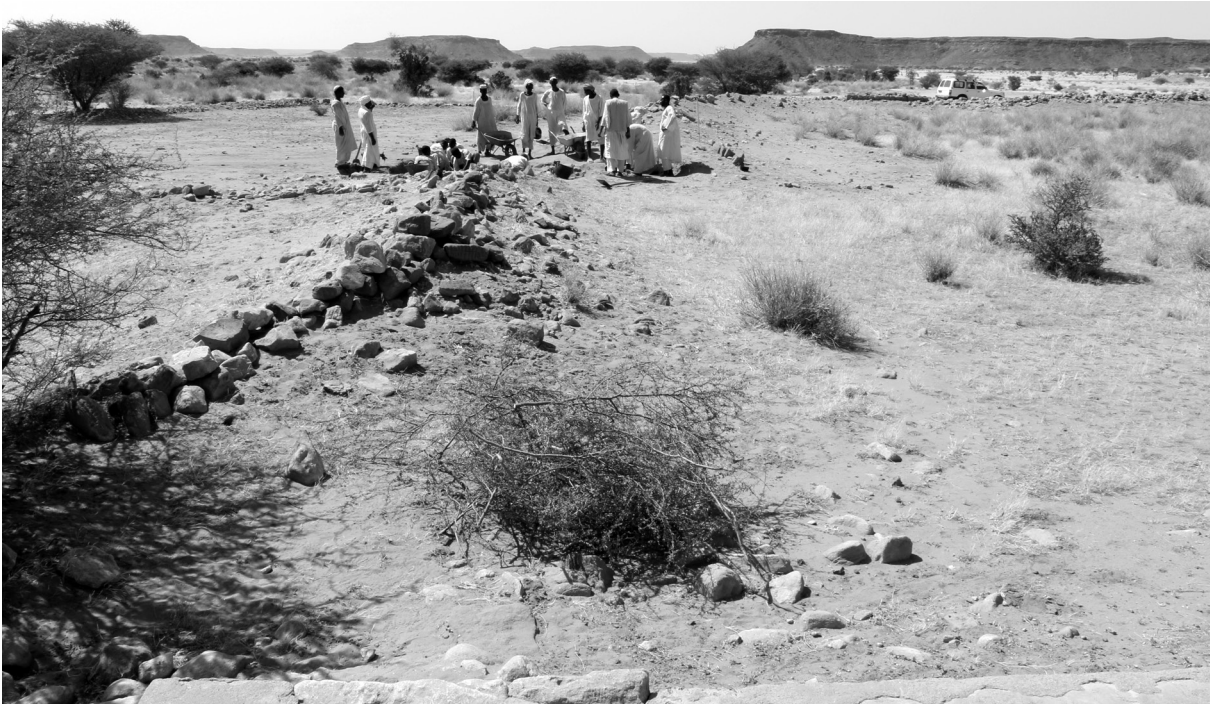
Fig. 7: The embankment of excavation debris delineating courtyard 415 towards southeast (photo: Claudia Näser)

excavation rubble stretching from the preserved corners of walls 415/E and 415/S, thus forming an arbitrary border of courtyard 415 (figs. 1, 7). Visually dominating, this embankment conveyed the feeling that it outlined the original courtyard wall despite the fact that it ran up to 20m west of it.

been taken from the cleared *kom* of excavation debris south of the Great Enclosure (see next section). Surface runoff in this *kbhor* had already damaged the service gate of the modern fence securing the area of the Lion Temple as well as the foundations of several fence posts. The effectiveness of the wall will be monitored and its construction adjusted if necessary.

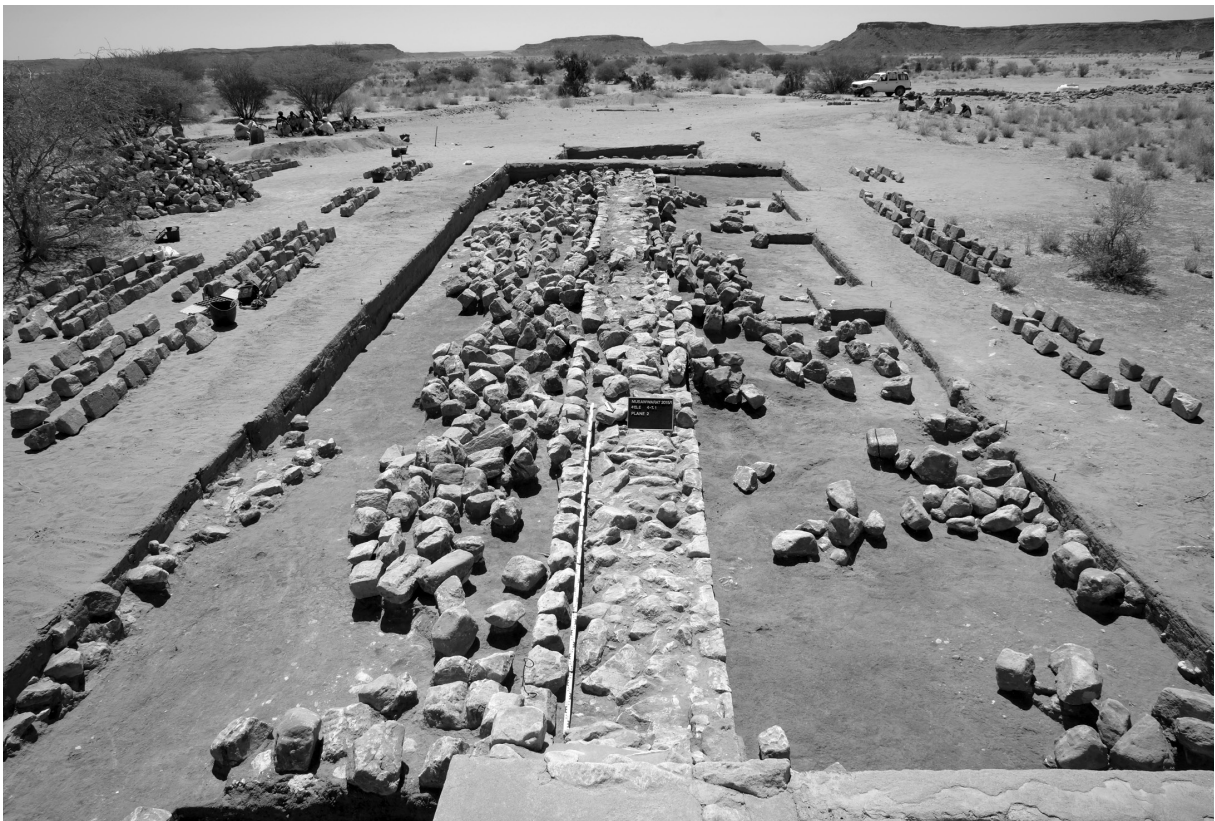
the 1960s. In addition, up to six layers of *en bloc* wall collapse were revealed (figs. 10–11) which had the potential to be reassembled in their original position. With these findings, more than 20m of the ancient enclosure wall and a hitherto unknown entrance gate were regained.

Fig. 10: Trenches 415.E4, 5, 6, 7, 1 (after documentation and removal of bulks) and 415.E3 in the south with the recovered segment of the enclosure wall 415/E (photo: Claudia Näser)

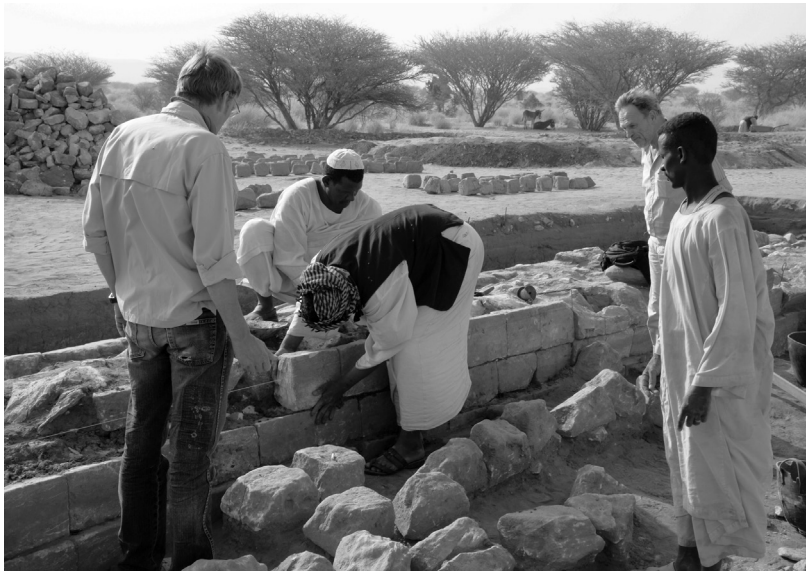
Fig. 13: Reconstruction of wall 415/E (photo: Claudia Näser)

After the excavation had been completed, the reconstruction of wall 415/E started (fig. 13), following the concept established in the previous years.<sup>15</sup> By the end of the season, the wall was reconstructed over a course of almost 20m up to six courses high. The remaining parts will be finished in the upcoming project year.

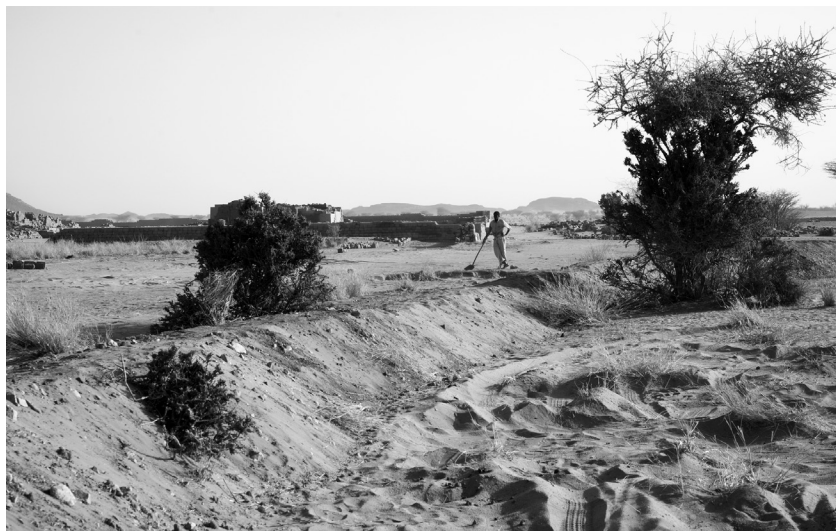
Fig. 14: The southwards extension of the protective wall towards the wadi east of the Great Enclosure (photo: Claudia Näser)

precipitation. Simultaneously, the protective rubble and sediment platform which had been constructed east of the Great Enclosure in spring 2014 to prevent the flooding of this area by surface runoff, and the low camouflaged stone wall which secured this platform towards the wadi<sup>16</sup> were extended more than 40m towards the south (figs. 1, 14) to consolidate and eventually enlarge the access area with the parking lot south of the Great Enclosure for future development.

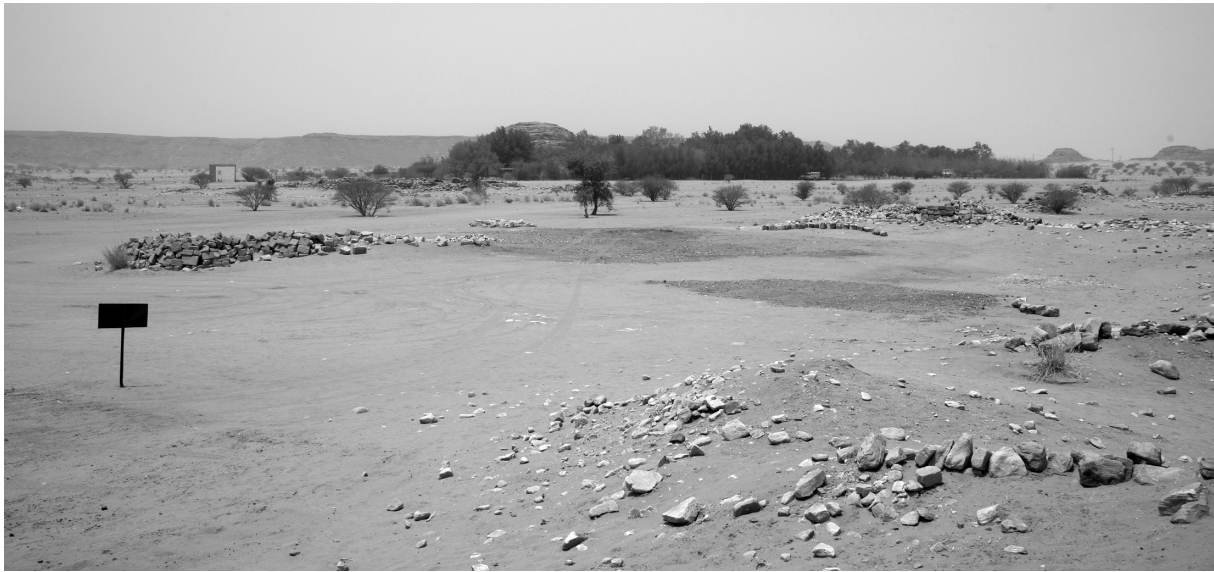
Fig. 15: The customary parking lot south of the Great Enclosure with the area of the cleared *kom* visible as dark patches; the stone repositories to the left were rebuilt later (photo: Claudia Näser)

removal of another *kom* of 1960s excavation debris in the western part of the current parking lot (fig. 1). More than 150m<sup>3</sup> of sand and rubble were moved to enlarge the platform and the protective wall at the edge of the wadi. On top, stone debris from this *kom* was used to build the diversion wall east of the Lion Temple (see previous section). The clearing of the *kom* was not merely an aesthetic measure, but a necessary intervention to prepare the area for the construction of the fence around the Great Enclosure, envisaged for the upcoming project year 2015/16,<sup>17</sup> as the *kom* had obscured the projected course of the fence at the southeastern corner of the adjacent courtyard 416 (figs. 1, 8, 15). The partly collapsed stone repositories in this area (fig. 1) were reconstructed *in situ*.<sup>18</sup>

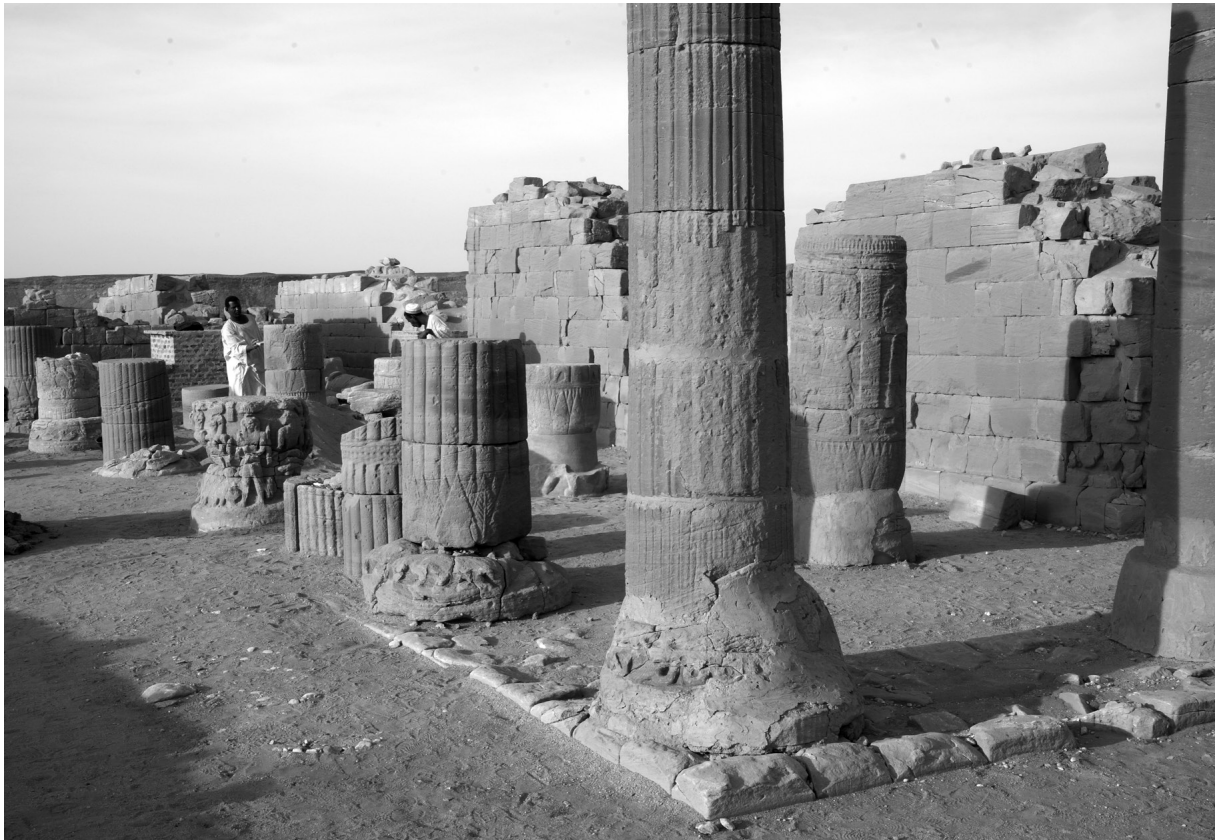
Fig. 17: The columns in front of Temple 100 with their protective encasings temporarily removed during the conservation survey; note the restored column 8 in the rear row (photo: Claudia Näser)

With the insights from column 8, a detailed condition assessment and work schedule for the treatment of the other seven columns, plus two additional columns of the outer peripteros circle, were prepared in the spring season 2015. This survey included an identification and detailed autopsy of all existing column fragments *in situ* (fig. 17), in the on-site museum and in the temporary stone repositories at the site. A detailed report of the findings and the resulting operational programme was drafted, and its implementation will continue with measures to consolidate the stone substance of the columns in autumn 2015. For the time being, all pieces on the Central Terrace, with the exception of the newly conserved parts of column 8, have once again been secured by protective brick encasings.

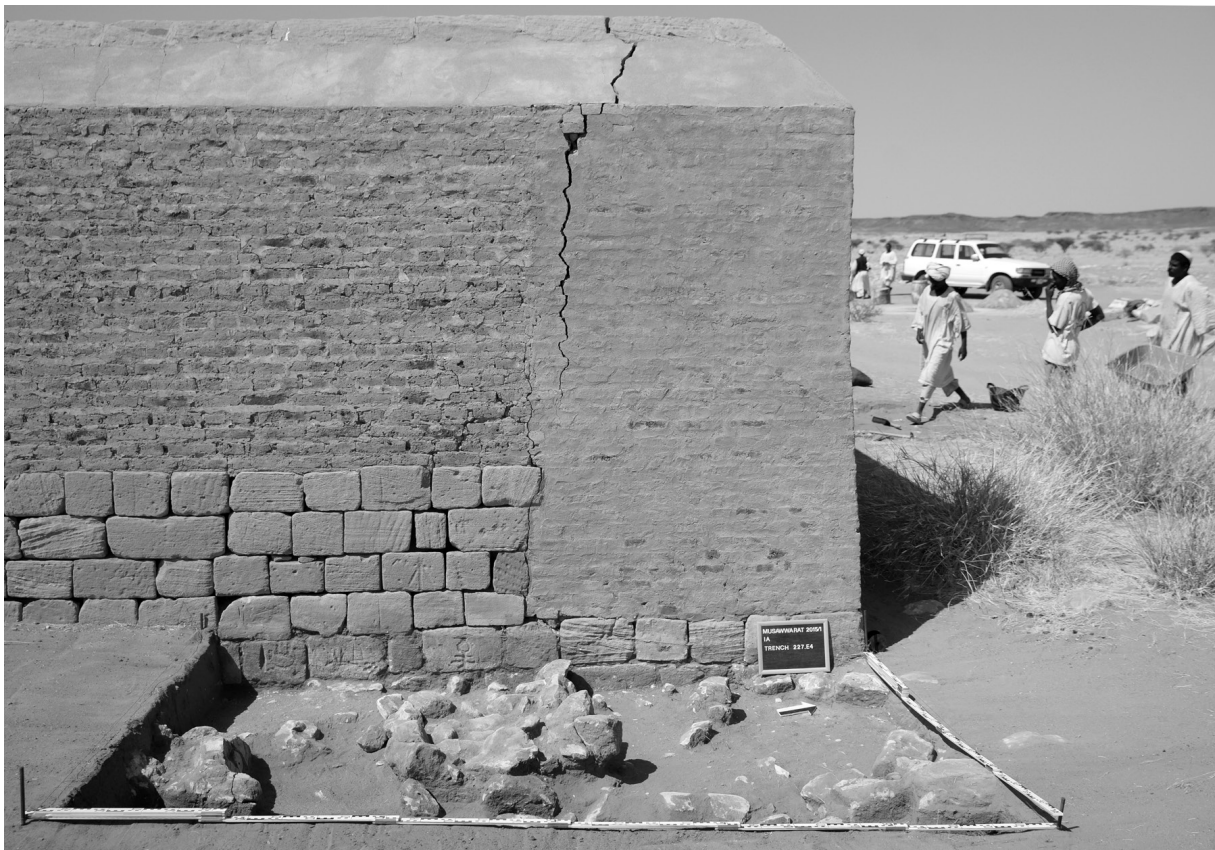
Fig. 18: Crack in the reconstructed enclosure wall at the northeastern corner of the Great Enclosure (photo: Claudia Näser)

Reconstruction of the outer wall of the Great Enclosure started in 1997. In 1998 its northeastern corner (fig. 8: 227/N+E) was re-erected, and in the following year the rebuilding was continued towards south.<sup>24</sup> Recently, a crack had developed at the inadequately formed joint between the 1998 and 1999 segments (fig. 18), primarily due to the settlement of the 1998 portion. This settlement was in turn provoked by rain water accumulations and fluvial erosion brought about by the uncontrolled outlet of the drainage from the site museum. Two mitigation measures were implemented. First, the drainage of the museum was shifted into a new outlet channel (fig. 19) which runs into a newly built infiltration well north of the enclosure wall (fig. 20). This well has a diameter of 1.8m and a depth of c. 3m, and is filled with brick rubble, covered with a plastic sheet and a layer of earth. After the cause for the settling had thus been remedied, the enclosure wall around the crack was taken down and re-built with a deliberate expansion joint (figs. 19, 21).

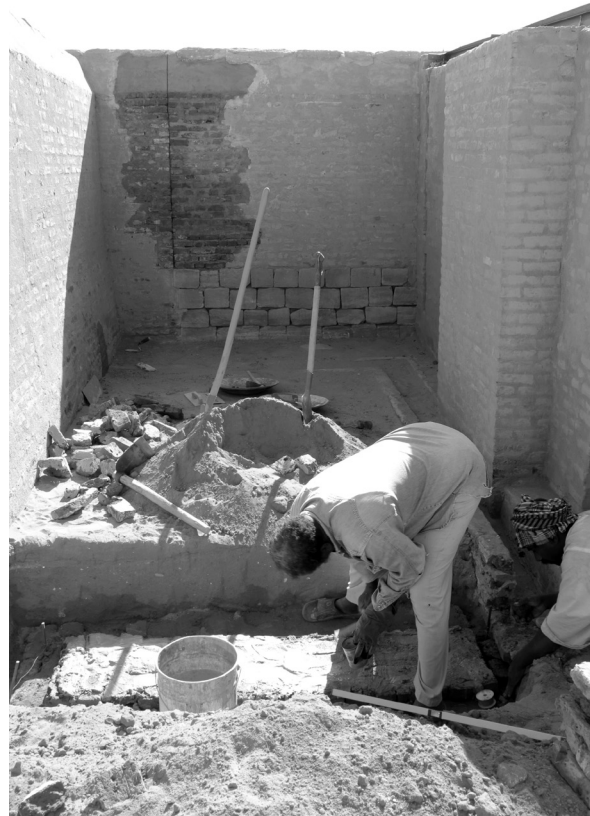
Fig. 19: Construction of the new outlet channel for the drainage of the site museum; note the re-modeled, though still unplastered area of the crack in the enclosure wall in the rear (photo: Claudia Näser)

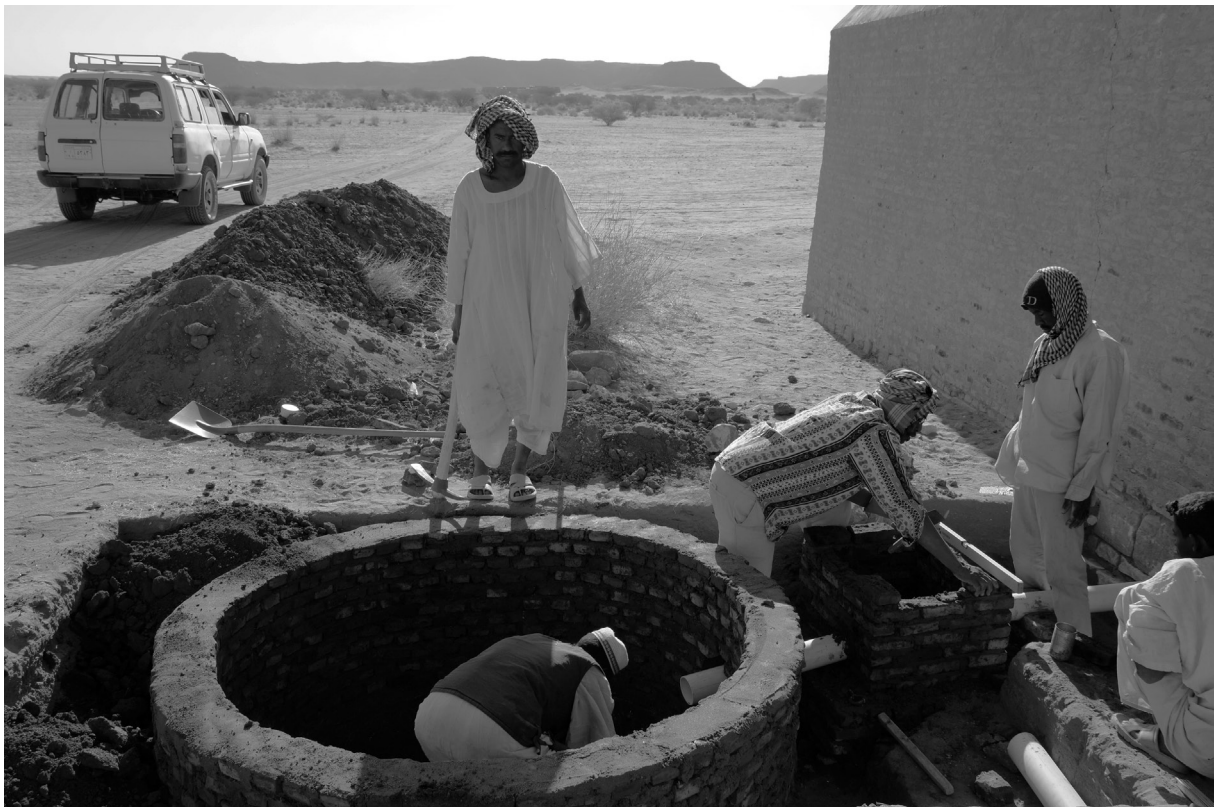
Fig. 20: Construction of the infiltration well outside the enclosure wall (photo: Claudia Näser)

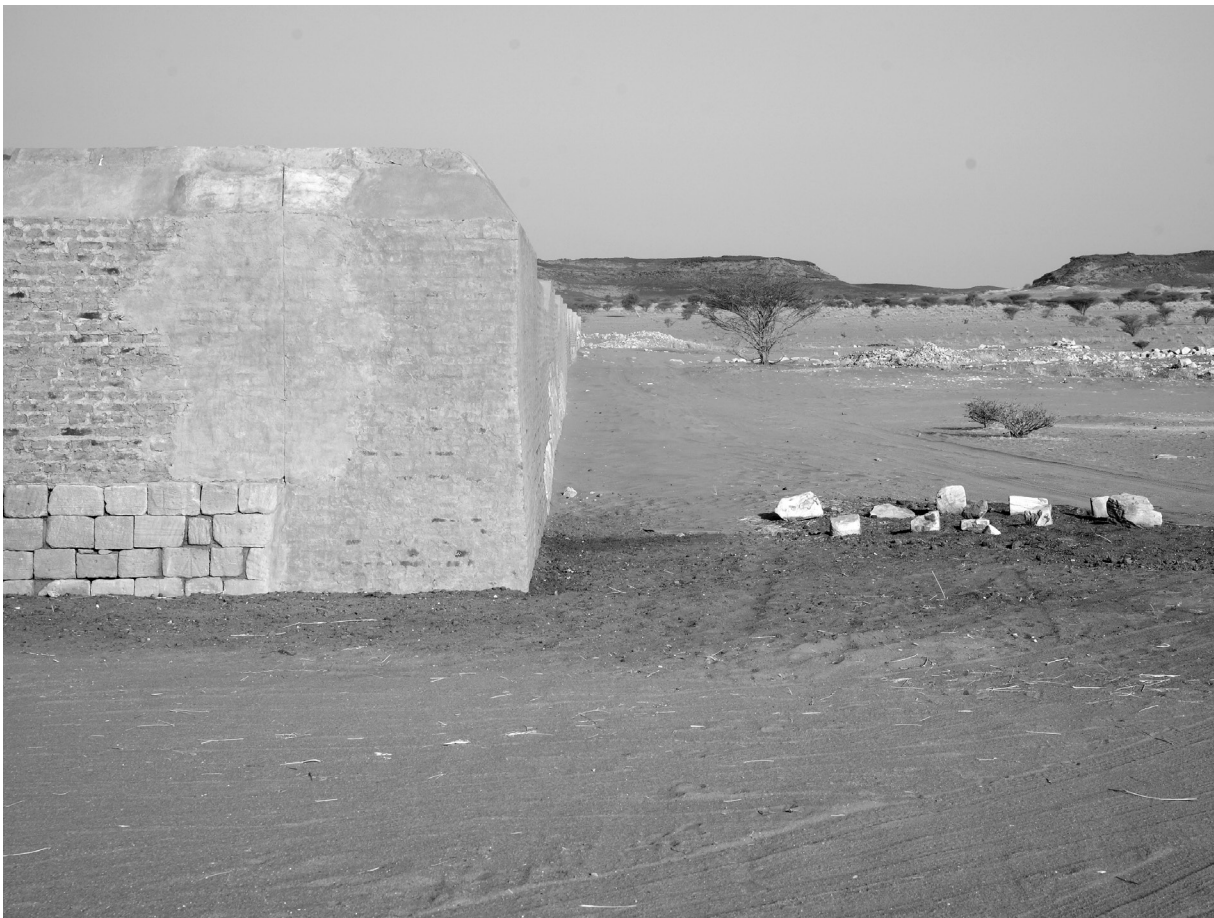
Fig. 21: The northeastern corner of the Great Enclosure after the completion of the measure (photo: Claudia Näser)

in the rehabilitation of this part of the site (fig. 21), which will be continued in connection with the construction of the fence in the coming project year. The material from these clearings was also used in the extension of the platform southeast of the Great Enclosure (cf. above p. 15).

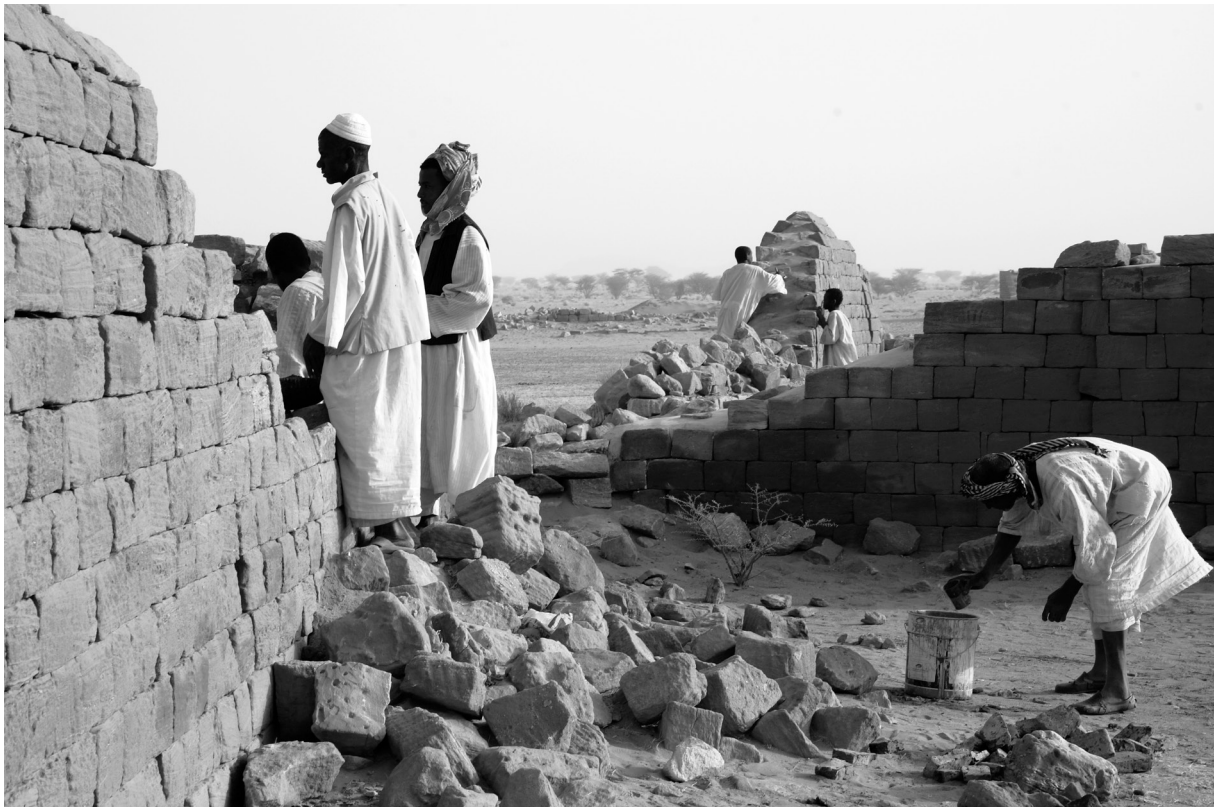
Fig. 22: Covering open wall tops with a lime mortar capping in Complex 500; in the centre and the background walls after treatment (photo: Claudia Näser)

In spring 2015, lime mortar capping concentrated on Complexes 200 and 500 of the Great Enclosure i.e. the buildings and courtyards surrounding Temple 200 and north of the Central Terrace (figs. 8, 22). Altogether, 190m of walls received a cover. Photographs were taken of all walls prior to their treatment in order to facilitate condition assessments and future monitoring.
